# Service Bulletin

Bulletin No.: 20-NA-121

**Subject:** Water Leak at Roof Area, Various Electrical Issues, No Start, Stall, Brake Lamp Not Off, Radio Inoperative, Remote Key Inoperative, TPM Light Illuminated, Malfunction Indicator Lamp (MIL) Illuminated with Possible DTCs C0750 SYM29, C0755 SYM29, C0760 SYM29, C0765 SYM29

Brand:	Model:	Model Year:		VIN:		Engine:	Transmission:
		from	to	from	to		
Buick	Encore GX	2020	2024	—	—	All	All
Chevrolet	Trailblazer (VIN M)	2021	2024	—	—	All	All

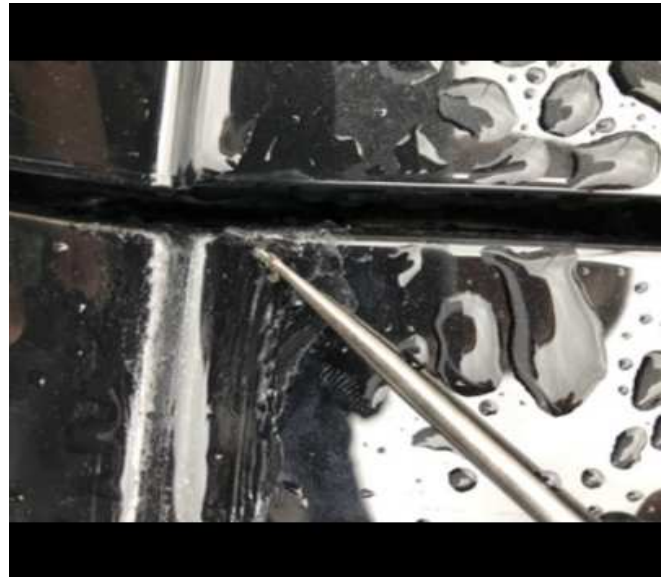
5613597

**Note:** Water leaks in the rear of vehicle were root caused to one large leak at driver side, rear upper liftgate area. The math file below shows the location of the leak, and the photo shows a view from the underside of the roof.

Once the damage is repaired, apply seam sealer along the roof to body seam to correct the condition.
