Subject: N242436241 - Customer Satisfaction Program
Multiple Module Reprogramming

Models: 2024 Chevrolet Blazer EV

Customer Satisfaction Program

N242436241 Multiple Module Reprogramming

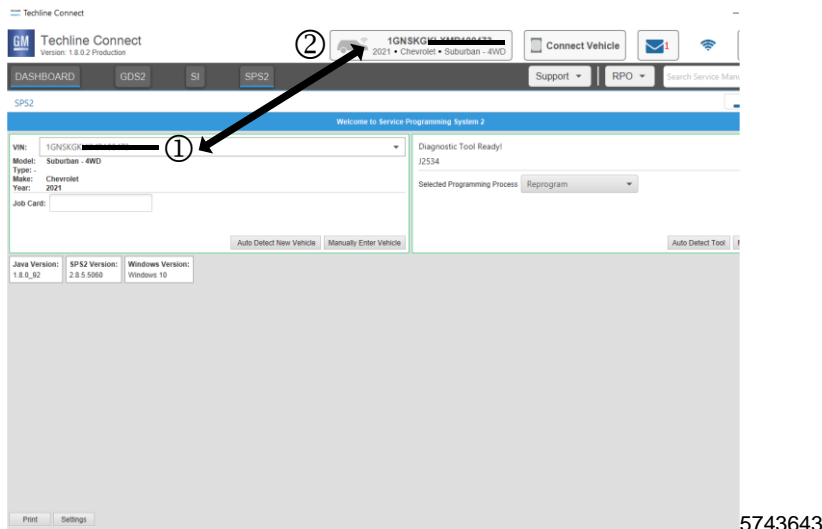
Caution: Be sure the VIN selected in the drop down menu (1) is the same as the vehicle connected (2) before beginning programming.

Important: If the vehicle VIN DOES NOT match, the message below will be shown.

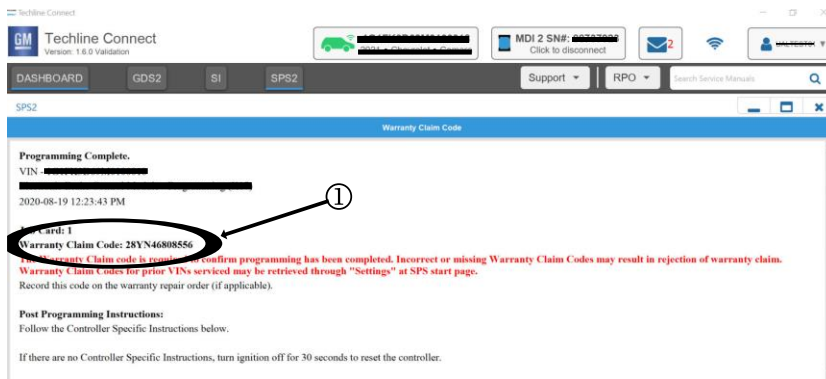
5644478

Note: The screenshot above is an example of module programming and may not be indicative of the specific module that is being programmed. Module selection and VIN information have been blacked out.

1. Restart Techline Connect.
2. Reprogram all equipped modules shown in the "Select Controller" section of SPS2 in Techline Connect. Refer to *Diagnostic Overview, Starting Point, and Programming > Programming and Setup > Repair Instructions* in SI for the applicable modules being reprogrammed.
3. If the front view camera module is reprogrammed, the front view camera module MUST be calibrated. Refer to *Front View Camera - Windshield Learn* in SI.
