# Service Bulletin

Bulletin No.: 24-NA-052

**Subject: Radio Software Version Z171 – Multiple Updates for IOK**

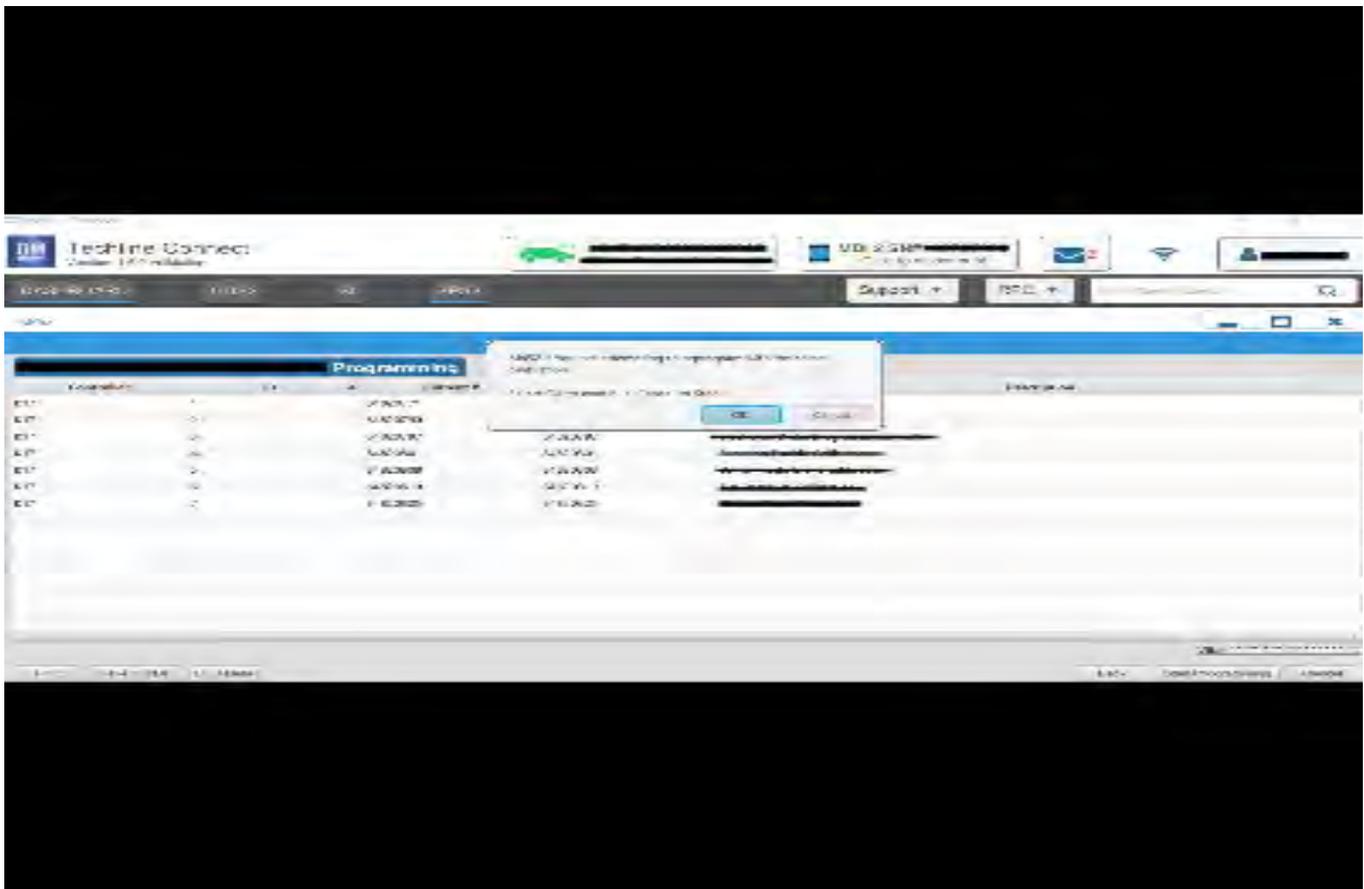
5644477

**Important:** Techline Connect screen shown above.

**Important:** If the same calibration/software warning is noted on the TLC Summary screen, select OK and follow screen instructions. After a successful programming event, the WCC is located in the Service Programming System dialogue box of the SPS Summary screen. Record the WCC on the job card. No further action is required. Refer to the Warranty Information section of this bulletin.
