NUMBER
PI1802Y/Z (Rev 7, 03/22/2024)

PRODUCT IMPROVEMENT CAMPAIGN

**SUBJECT: ENGINE REPLACEMENT INSTRUCTIONS
FOR DTC P1326 (PI1802Y/Z)**

This bulletin provides information related to the Technical Service Bulletin previously published [PI1802](#) titled "Knock Sensor Detection System - ECU Logic Improvement" equipped w/THETA II engine. Specifically, this bulletin provides instructions on which procedures to follow if, after installation of the KSDS, any one of the subject vehicles below returns to the dealer with Diagnostic Trouble Code (DTC) P1326 (Knock Signal Range/Performance).

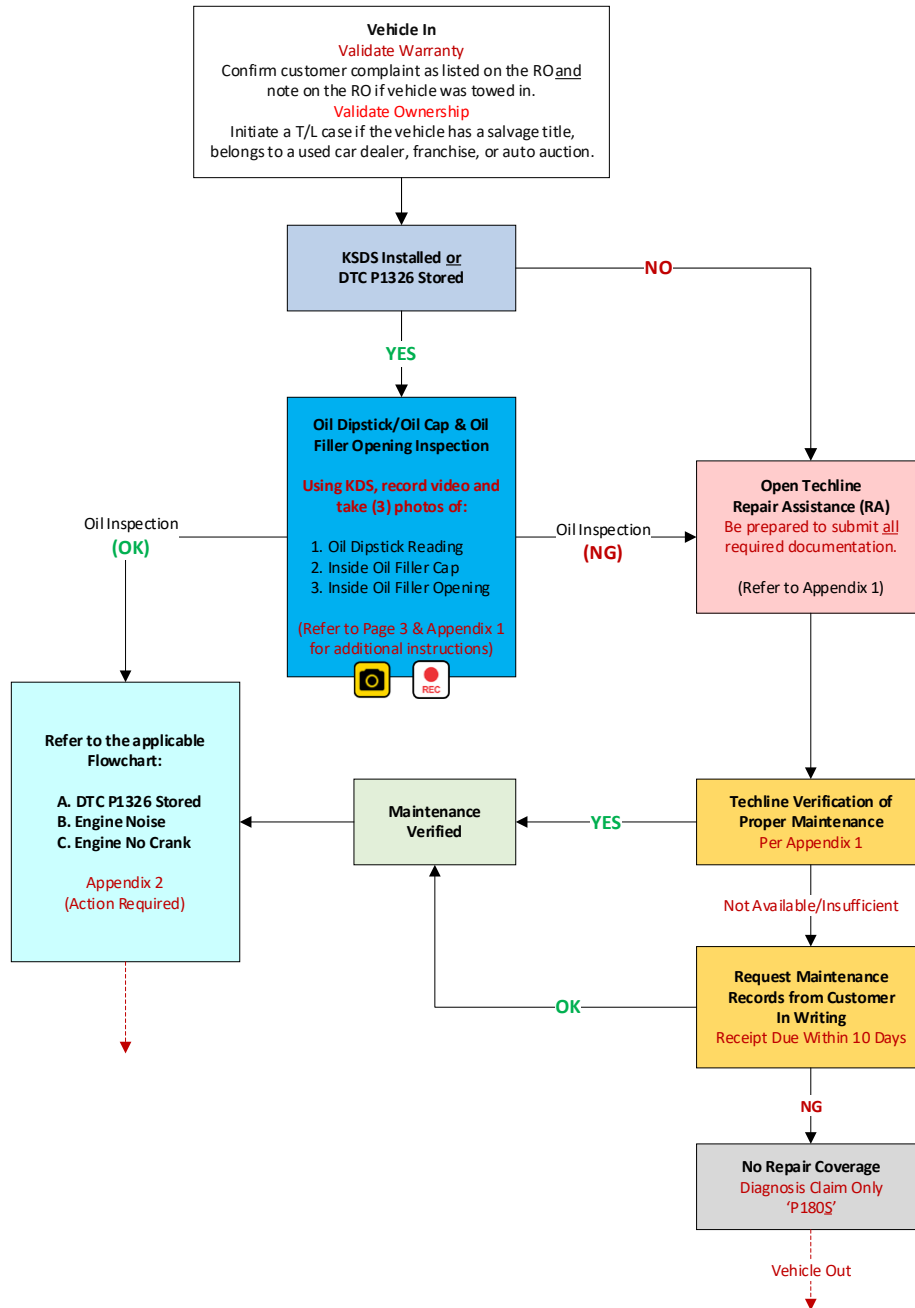
Follow the applicable flowchart upon documenting customer complaint for one (1) of the three (3) following concerns from Main Flowchart:

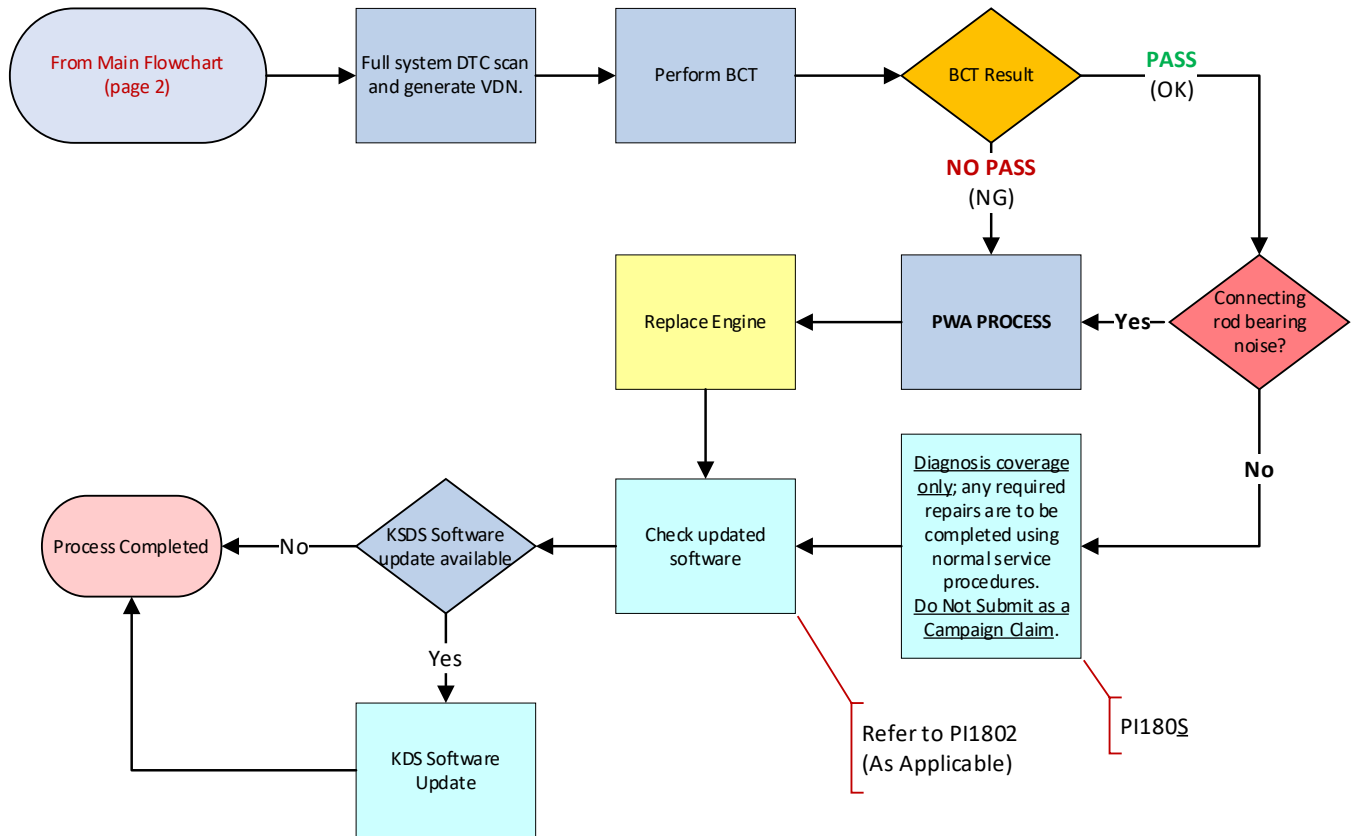
B. Engine Noise

Techline PWA Required; Diagnosis Only Campaign Possible

Due to recent updates to KDS, always follow the BCT procedure instructions outlined in KDS. You may also refer to [SST067 for BCT Procedure/Calibration information.](#)

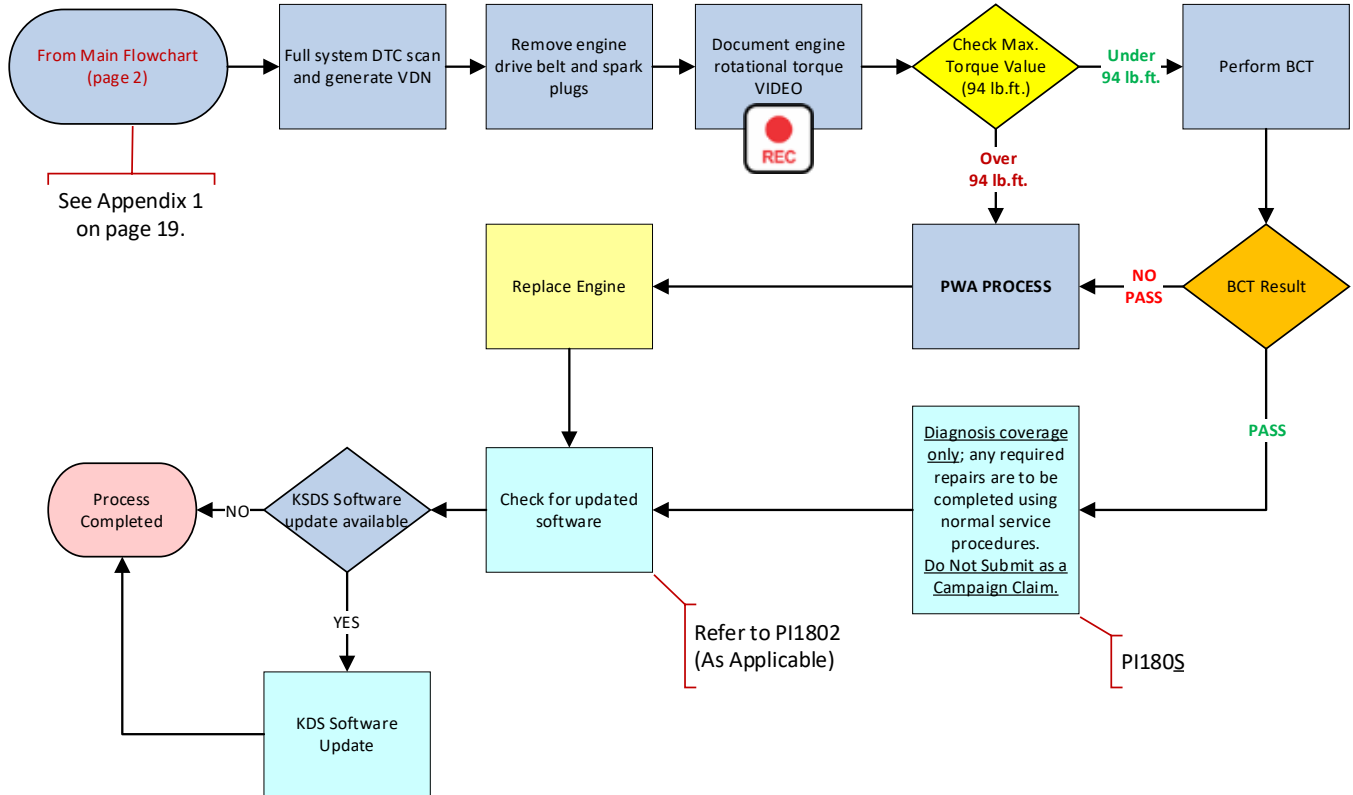
C. Engine No Crank

Techline PWA Required; Diagnosis Only Campaign Possible

Due to recent updates to KDS, always follow the BCT procedure instructions outlined in KDS. You may also refer to [SST067](#) for BCT Procedure/Calibration information.

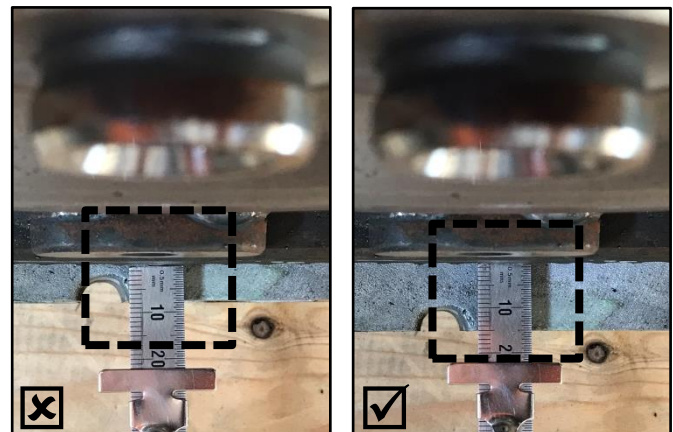
Torque Converter

Not Fully Inserted

Fully Inserted

- If the torque converter has moved from the fully inserted position, carefully push inward while rotating the torque converter until it is recessed approximately 9/16 – 5/8" (14 – 16mm) (☑) into the transaxle case when reinstalling the automatic transaxle.
