**TECHNICAL INSTRUCTIONS**  
**FOR**  
**CUSTOMER SUPPORT PROGRAM 22TE09**  
**HV FLOOR UNDER WIRE HARNESS AND REAR TRACTION MOTOR CABLE**  
**CORROSION**  
**CERTAIN 2021 – 2022 MODEL YEAR VENZA HYBRID**

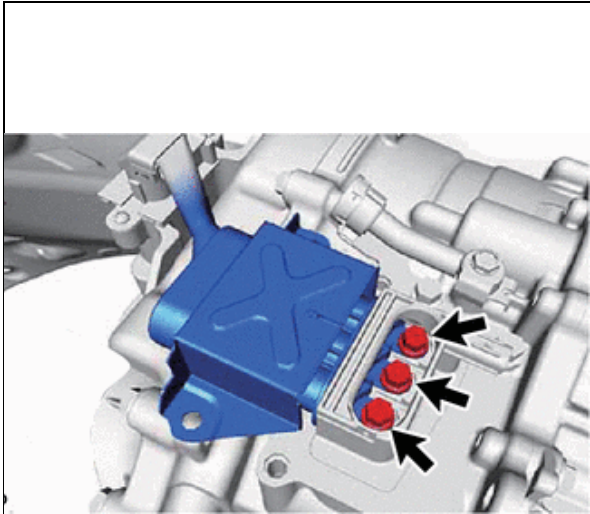
#### 1. Install the Rear Traction Motor Cable onto the MGR

- a) Clean the area around the terminal of the rear traction motor cable, and then blow air on the terminal to remove dust and other foreign matter.

- b) Using an insulated tool, install the rear traction motor cable to the rear traction motor with transaxle assembly with the 3 bolts.

10 N·m {102 kgf·cm, 7 ft·lbf}

**Torque is critical at this electrical connection. Ensure proper torque is applied to each bolt.**
