Technical Service Bulletin

GROUP BODY	NUMBER 24-BD-004H
DATE MARCH 2024	MODEL(S) SANTA CRUZ (NXT)

SUBJECT: TONNEAU COVER INSPECTION, REALIGNMENT, AND ASSEMBLY REPLACEMENT

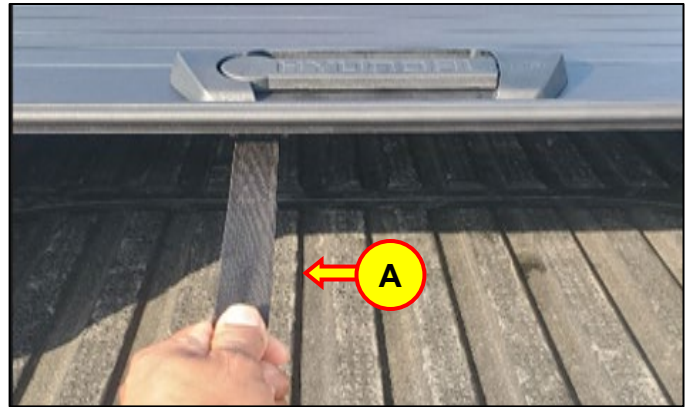
1. Open the tailgate and use the pull strap (A) to close the tonneau cover.

Ensure that the latch pins on both sides lock securely at the end of the bed rails.

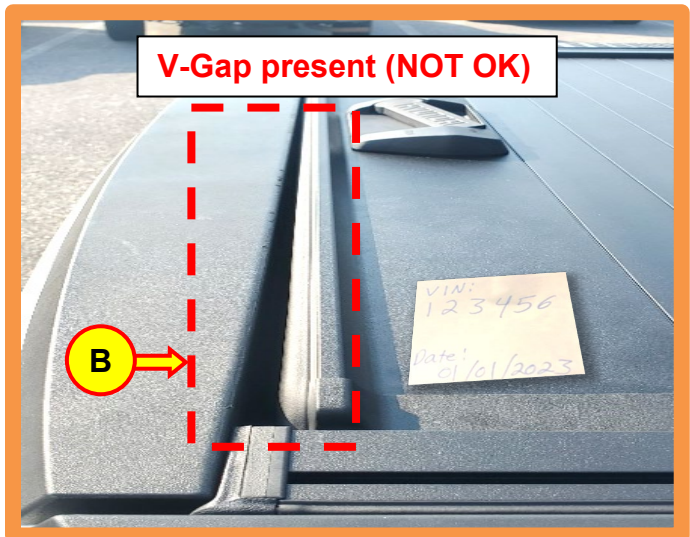
If no V-Gap is present, this inspection is complete. Proceed to the **Retraction Inspection** on the next page.

If a V-Gap (B) is present, perform the **Tonneau Cover Realignment** procedure on page 5.

Using STUI, take a photo of the V-Gap condition (if it is present or not) with the last 6 digits of the VIN and the date of repair on a piece of paper.

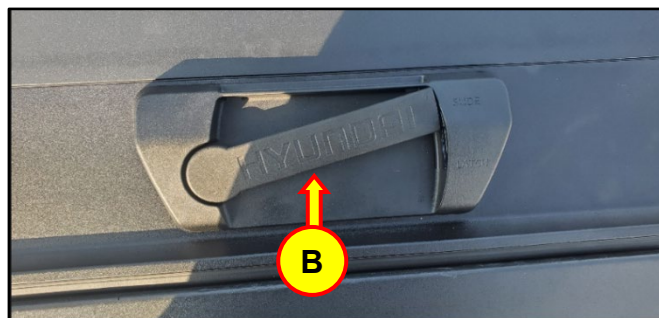
3. If the tonneau cover retracts easily or needs a gentle push to retract, this inspection is complete. No repairs are required. Proceed to the **Proper Tonneau Cover Operation** section on the last page.

If the tonneau cover does **NOT** retract or requires excessive effort while pushing to retract, perform the **Tonneau Cover Realignment** procedure on the next page.

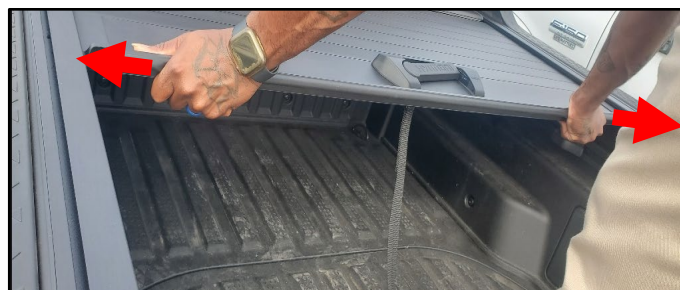
If the V-Gap is still present and/or the tonneau cover is still not retracting after performing the realignment procedure, then replace the tonneau cover assembly.

3. With both hands, hold the tonneau cover and shift it left to right while slowly pushing it into the canister.

Continuously shift the tonneau cover until it is completely retracted.

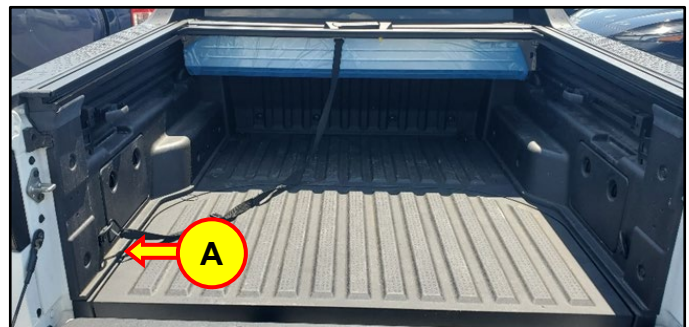
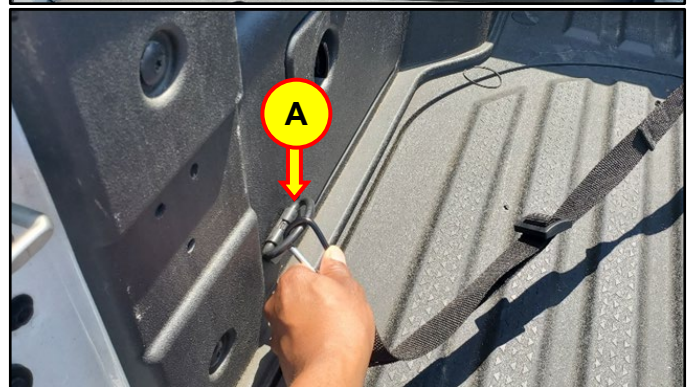
Alignment/retraction problems may occur if the tonneau cover is repeatedly closed incorrectly.

Do **NOT** slam cover closed with excessive force, which may cause damage to the tonneau cover.

2. Secure the pull strap (A) to either side of the bed when not in use.

Pulling the strap to the left will reset the latch center handle position.
