GROUP	NUMBER
BODY ELECTRICAL	24-BE-005H
DATE	MODEL(S)
MARCH 2024	ELANTRA (CN7/CN7A)

SUBJECT: FRONT RADAR REPLACEMENT & ADJUSTMENT FOR DTC C1620

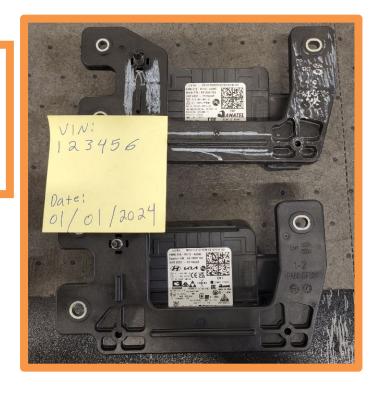
Using STUI, take a photo of the old and new front radar unit with the last 6 digits of the VIN and the date of repair on a piece of paper.

Upload the photo to STUI.

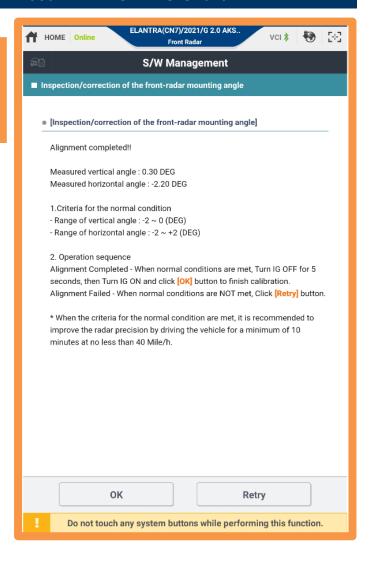
3.

Take a screenshot of the Alignment complete screen using your tablet and upload to STUI.
