**SERVICE BULLETIN**

**APPLICABILITY:** 22-23MY WRX Models **NUMBER:** 15-301-22R  
**SUBJECT:** Reprogramming File Availability for Optimization of Gen 4 Denso CP1 Infotainment Systems **DATE:** 09/09/22  
**REVISED:** 03/15/24

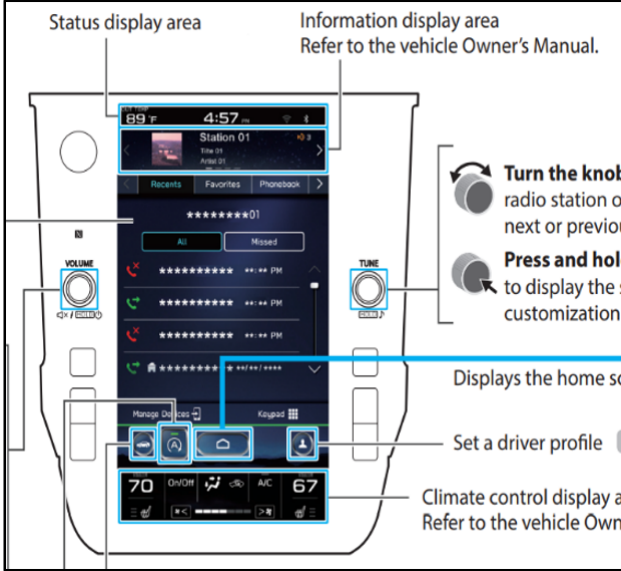
Number	Symptoms to be Improved:
<b>1</b>	<b>While welcome animation on CID is displayed and the driver's door is left open, if turning ignition OFF/ON, the CID screen will be black screen.</b>
<b>2</b>	<b>After starting the engine, the loading animation remains and the screen does not transition remaining blank.</b>
<b>3</b>	<b>When the “All” tab is pressed on the TravelLink Sports screen, a blank screen appears.</b>
<b>4</b>	<b>During Bluetooth audio playing, the CID screen turns into a black picture.</b>
<b>5</b>	<p><b>The Information Display Area at the top of the CID screen displays a different information screen from the last time.</b></p>

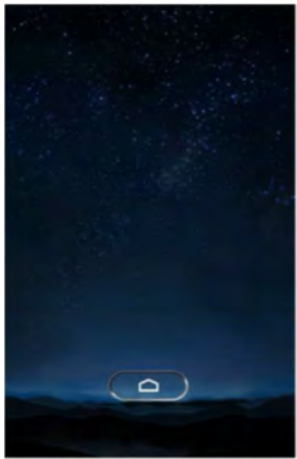
Number	Symptoms to be Improved:
1	Unexpected CP1 system reboot resulting from an inter reset to sync internal communication with Bluetooth module.
2	CID restarts itself right after engine is started.
3	CID resets and reboots.
4	<p>Right after starting up, the CID is blank only displaying the background without icons.</p>

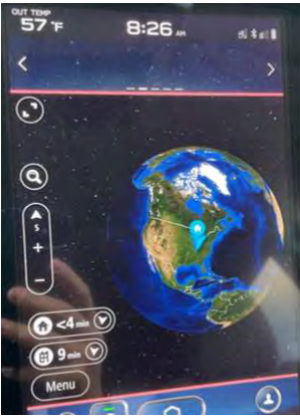
Number	Symptoms to be Improved:
7	Sound is lost when playing Bluetooth audio even though the screen is displayed without problem. It can occur when the audio source is switched repeatedly between the Bluetooth and others.
8	SXM radio output is lost after terminating a handsfree phone call.
9	No audio played back when using CarPlay.
10	Sound volume control does not work while using Android Auto.
11	Cyclic short noise like a drilling or vibration is heard from speakers.
12	After the engine is started, a message of “Loading Navigation...” continues to be displayed, but the map is not displayed.
13	Vehicle position on navigation map erroneously moves to zero degrees latitude and zero degrees longitude (0°N 0°E or west of Africa in the Atlantic ocean).
14	<p>Navigation map scale is changed to the lowest setting (globe is displayed).</p>

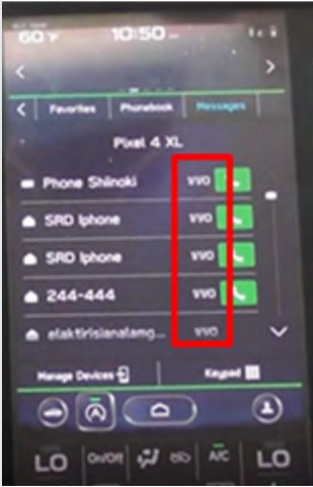
16	<p>When selecting “Phone-&gt;”Message,” message received time is displayed incorrectly as “1/1/0.”</p> <p>It can occur with an Android phone with a specific Android OS (Pixel 6, Pixel4a, Pixel4XL, Xperia etc. ) in which time zone data is attached to the message receiving time.</p>

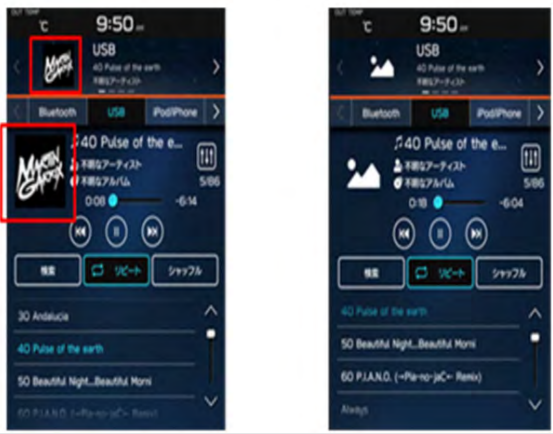
Number	Symptoms to be Improved:
17	Even when using the same mobile device that was paired previously, a message of “Are you sure you want to activate this profile?” is prompted and confirmation is needed to activate the device.
18	<p>Cover art of previous music is displayed when playing music without cover art in USB audio. It can occur when music with and without cover art is mixed and stored together a single USB.</p>

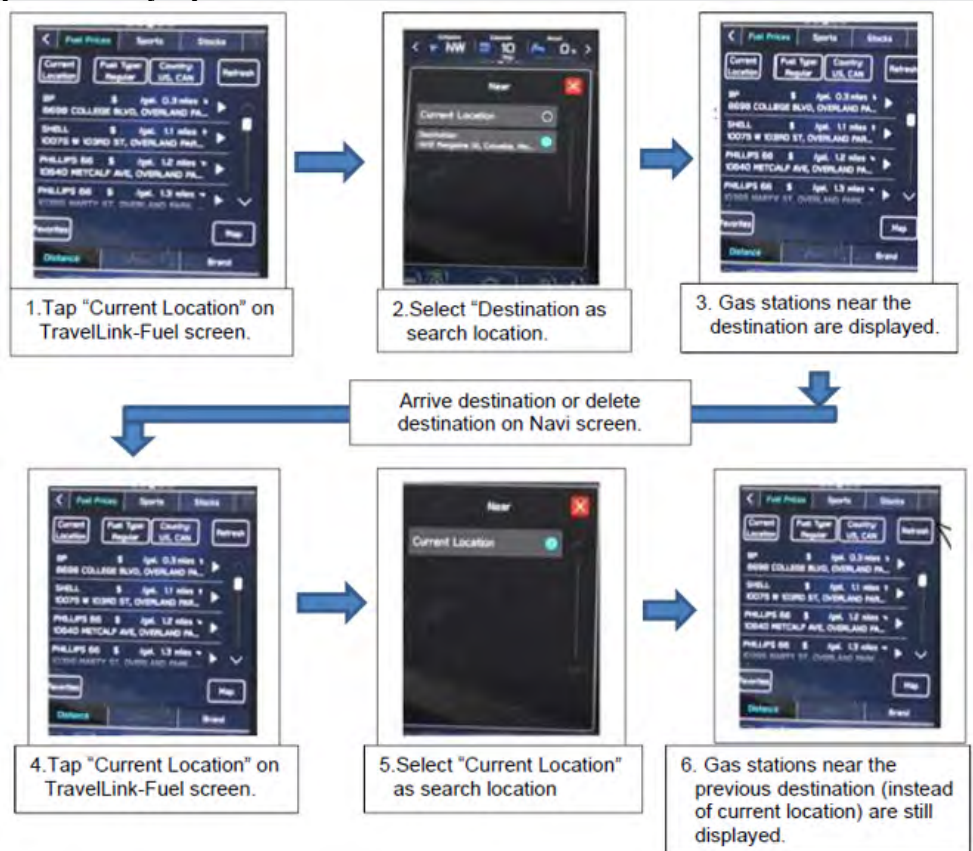
30	<p>A wrong search location is used on TravelLink function. Facilities around the previous destination are searched instead of those around the current destination.</p> <p>Example of the symptom.</p>

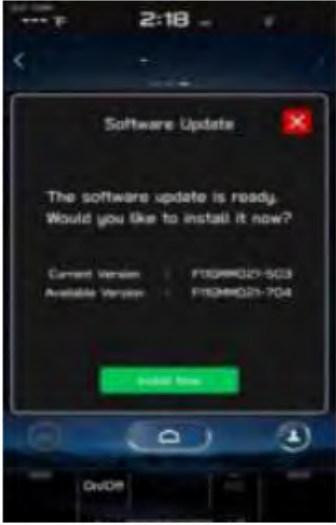
<p><b>Note*</b> Even if this symptom occurs, after approximately 2 minutes, the system resumes, and the CID comes back to the below screen. Customer can then push the “Install Now” to proceed with the installation.</p>
