PRODUCT CAMPAIGN BULLETIN

APPLICABILITY: 2021MY Crosstrek
 2022MY Forester
 2021-23MY Legacy
 2021-23MY Outback

NUMBER: WRQ-23R

SUBJECT: Safety Recall – Transmission Inhibitor Switch Replacement

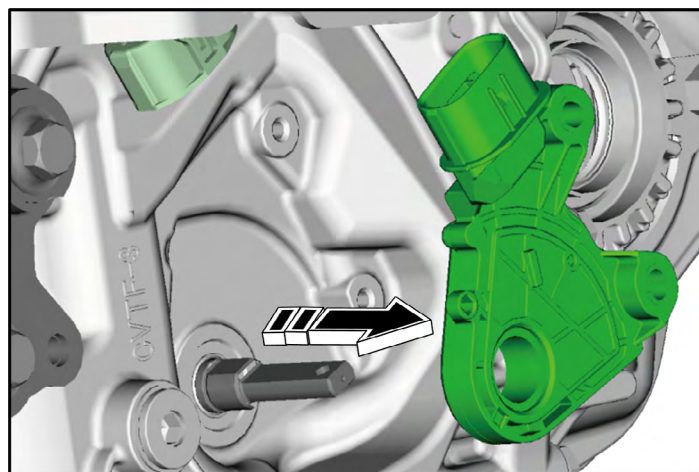
The vehicles included in this recall may contain an inhibitor switch that was manufactured with an insufficient weld between the switch stator and cover which may allow water intrusion.

Over time, moisture intrusion may cause the inhibitor switch to become inoperative. An inoperative inhibitor switch may result in the backup lamps not illuminating when in reverse gear, the rear-view monitor not displaying, the transmission gear select indicator in the instrument panel not being displayed, or inability to start the engine.

STEP 16: Remove and discard the original inhibitor switch.

TIP: The inhibitor switch may be difficult to separate from the shaft. Slightly rocking the switch back and forth can help make removal easier if this occurs.
