Technical Service Bulletin

87 Air conditioning refrigerant circuit diagnostic method using calibration gas

87 24 70 2064077/4 March 29, 2024. Supersedes Technical Service Bulletin Group 87 number 23-60 dated October 23, 2023 for reasons listed below.

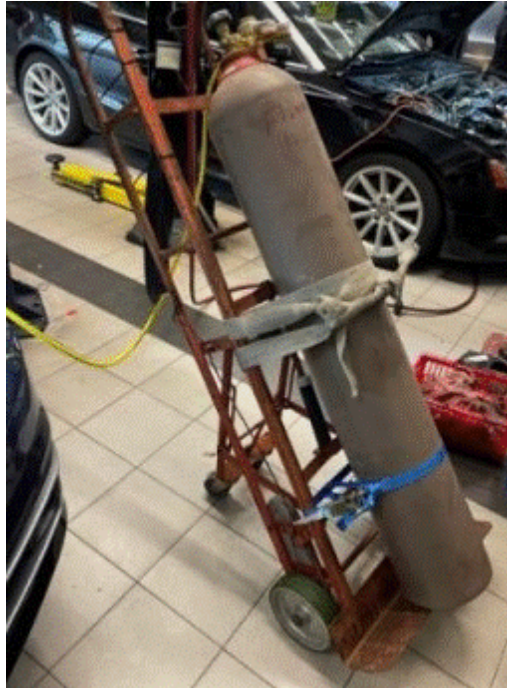
Figure 1. Calibration gas (95% Nitrogen / 5% Hydrogen).

2. Obtain a tank of calibration gas (95% nitrogen / 5% hydrogen) (Figure 1). This will need to be sourced locally (e.g., Airgas®).

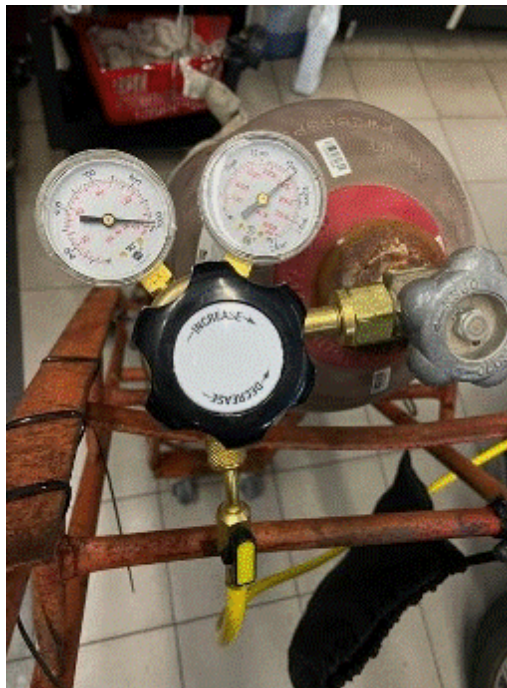
Figure 2. VAS 584005 pressure regulator attached to the calibration gas tank.

3. The pressure regulator included in the NITROKITG will not be used as it is only suitable for connection to a gas tank containing non-flammable gasses such as nitrogen (right-hand thread). The AT-448 Tool Set includes the VAS 584005 pressure regulator suitable for connection to a gas tank containing any flammable component as is the case with the hydrogen component in calibration gas (left-hand thread). Connect the VAS 584005 pressure regulator to the tank (Figure 2). Make sure the tank valve remains closed.

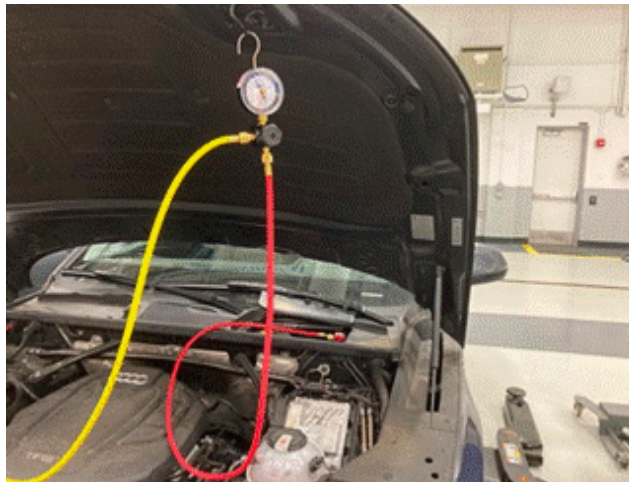
Figure 3. NITROKITG manifold connected to the high side service port.

6. The NITROKITG includes a service hose and high side service port snap coupler for both an R134a and R1234yf refrigerant system. This will allow the single connection to the refrigerant circuit of both an R134a as well as an R1234yf equipped vehicle. Use the snap coupler appropriate for the refrigerant platform being serviced from the NITROKITG to complete the connection.
7. Evacuate the vehicle refrigerant circuit for 15 minutes. After the refrigerant circuit is free of any refrigerant connect the service manifold from the NITROKITG Automotive A/C Nitrogen Leak Test Kit to the high side service port. Use the appropriate snap coupler for the platform of the circuit being serviced. (Figure 3).

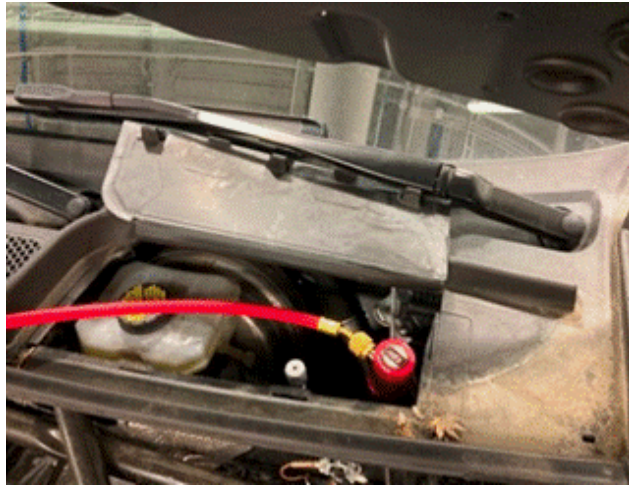
Figure 4. NITROKITG high side snap coupler connected to the high side service port.

8. Only one of the ports needs to be connected for this diagnosis. The connection to the high side port is shown in Figure 4.

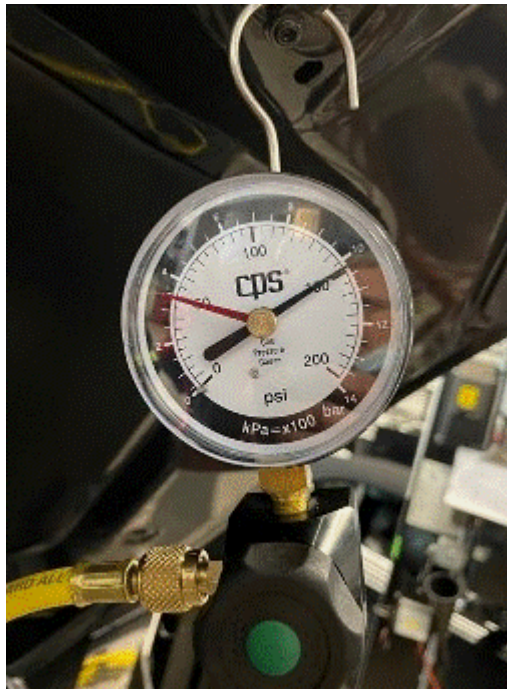
Figure 5. Calibration gas pressure in the circuit.

9. Connect the VAS 584005 Pressure Reducer to the NITROKITG manifold. Fill the circuit with calibration gas to an absolute pressure of no greater than 14 bar (Figure 5).
