Technical Service Bulletin

SUBJECT:			No:	TSB-20-23-001REV3
POTENTIAL TR	ANSMISSION SH		DATE:	March 2024
WITH POSSI	BLE DTC (CVT-8)) – REVISED	MODEL	See below
CIRCULATE TO:	[] GENERAL MANAGER	[X] PARTS MANAGER		[X] TECHNICIAN
[X] SERVICE ADVISOR	[X] SERVICE MANAGER	[X] WARRANTY PROCESSOR		[] SALES MANAGER

Certain vehicles with F1CJC/W1CJC (CVT-8) transmissions may exhibit a shudder or surge condition possibly caused by poor reaction of the hydraulic pressure circuit. With continued driving under these conditions, the CVT belt may slip repeatedly when accelerating, and abrasion powder may enter the hydraulic pressure circuit, causing a warning light to turn on with one of the following DTCs: P0776, P0730, P0741, P084A, P0969, P2719. The shudder/ surge condition may also be described as engine flare, lack of acceleration, and/or car shake.

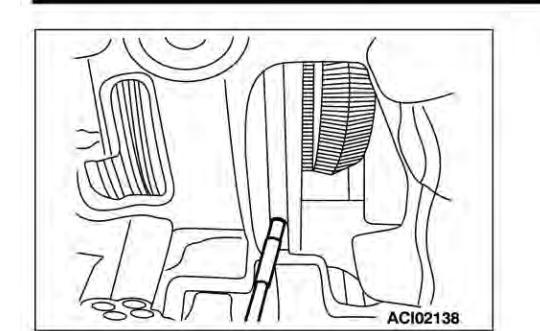
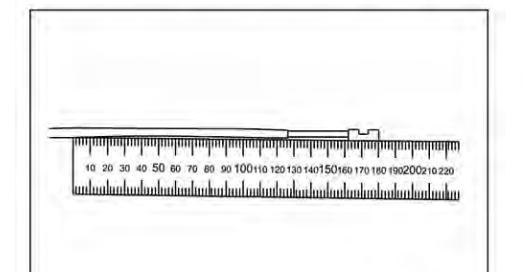
- 1. Inspect the near engine side vehicle right side of flanks surfaces of the belt.
 - Straighten the cable and face the scope towards side of the primary pulley.

(2) Enter the scope in between rear of the primary pulley and CVT case.

- If damage is found on either side of mating surfaces of the belt, CVT assembly replacement is required.
- If no damage is found on mating surfaces of the belt, a new valve body Installation is required. Follow next steps.
