SIB 51 11 23

2024-04-11

CRACKING SOUND IN D-PILLAR TRIM PANEL AND/OR CARGO AREA CAPPING TRIM PANEL

E-Series	Model Description	Production Date
i20	iX Sports Activity Vehicle	SOP (Start of Production) – up to and including August 31, 2023

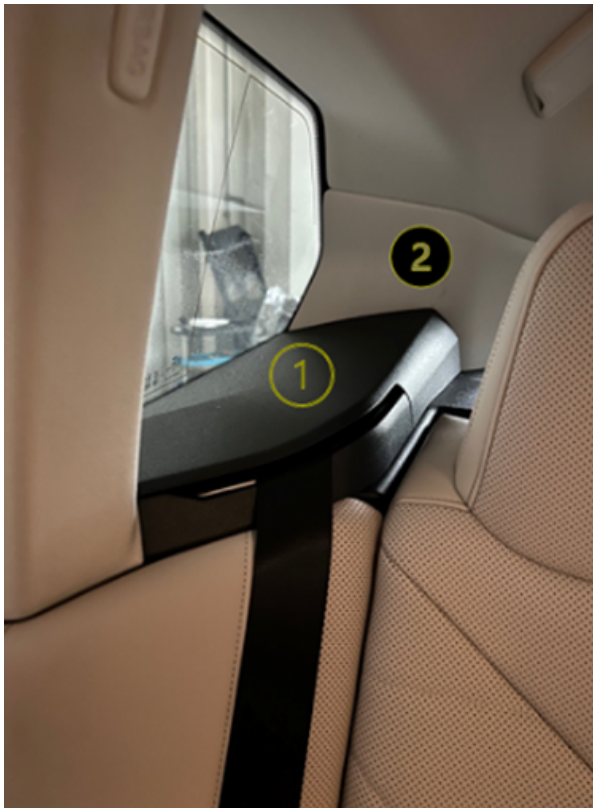
There are two situations:

1. While driving on a smooth paved road, a cracking sound can be heard coming from the right-side luggage compartment capping trim panel.
2. While driving on a smooth paved or rough road, a cracking sound can be heard coming from the D-pillar trim panel. The sound can occur on one or both sides (left and/or right).

The cracking sound for both components sounds the same and can only be differentiated by the road condition.
