## Steering Stub Shaft Hardware Replacement

**Mack**

| Model Years | Models |
|---|---|
| 2024-2025 | GR, PI |

Mack trucks has determined that certain GR, PI model trucks could have the incorrect steering shaft support bearing mounting hardware installed. On affected vehicles follow the instructions below to remove the steering shaft support bearing mounting hardware and replace with new screws and nuts.

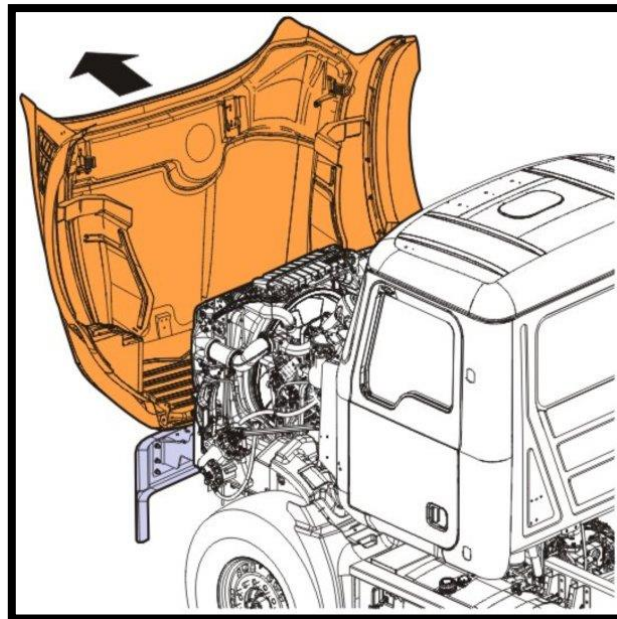
8. Locate the two screws securing the steering shaft support bearing to the bracket.
9. Remove the two flange nuts and screws.

- 10. Discard the nuts and screws.
- 11. Install the new screw **984754** GR or **995494** PI and **990951** nuts.
