## SERVICE BULLETIN

**APPLICABILITY:** 2024MY Crosstrek & Impreza

**NUMBER:** 09-118-24

**SUBJECT:** DTCs P2404 & P0087 / Reprogramming Files

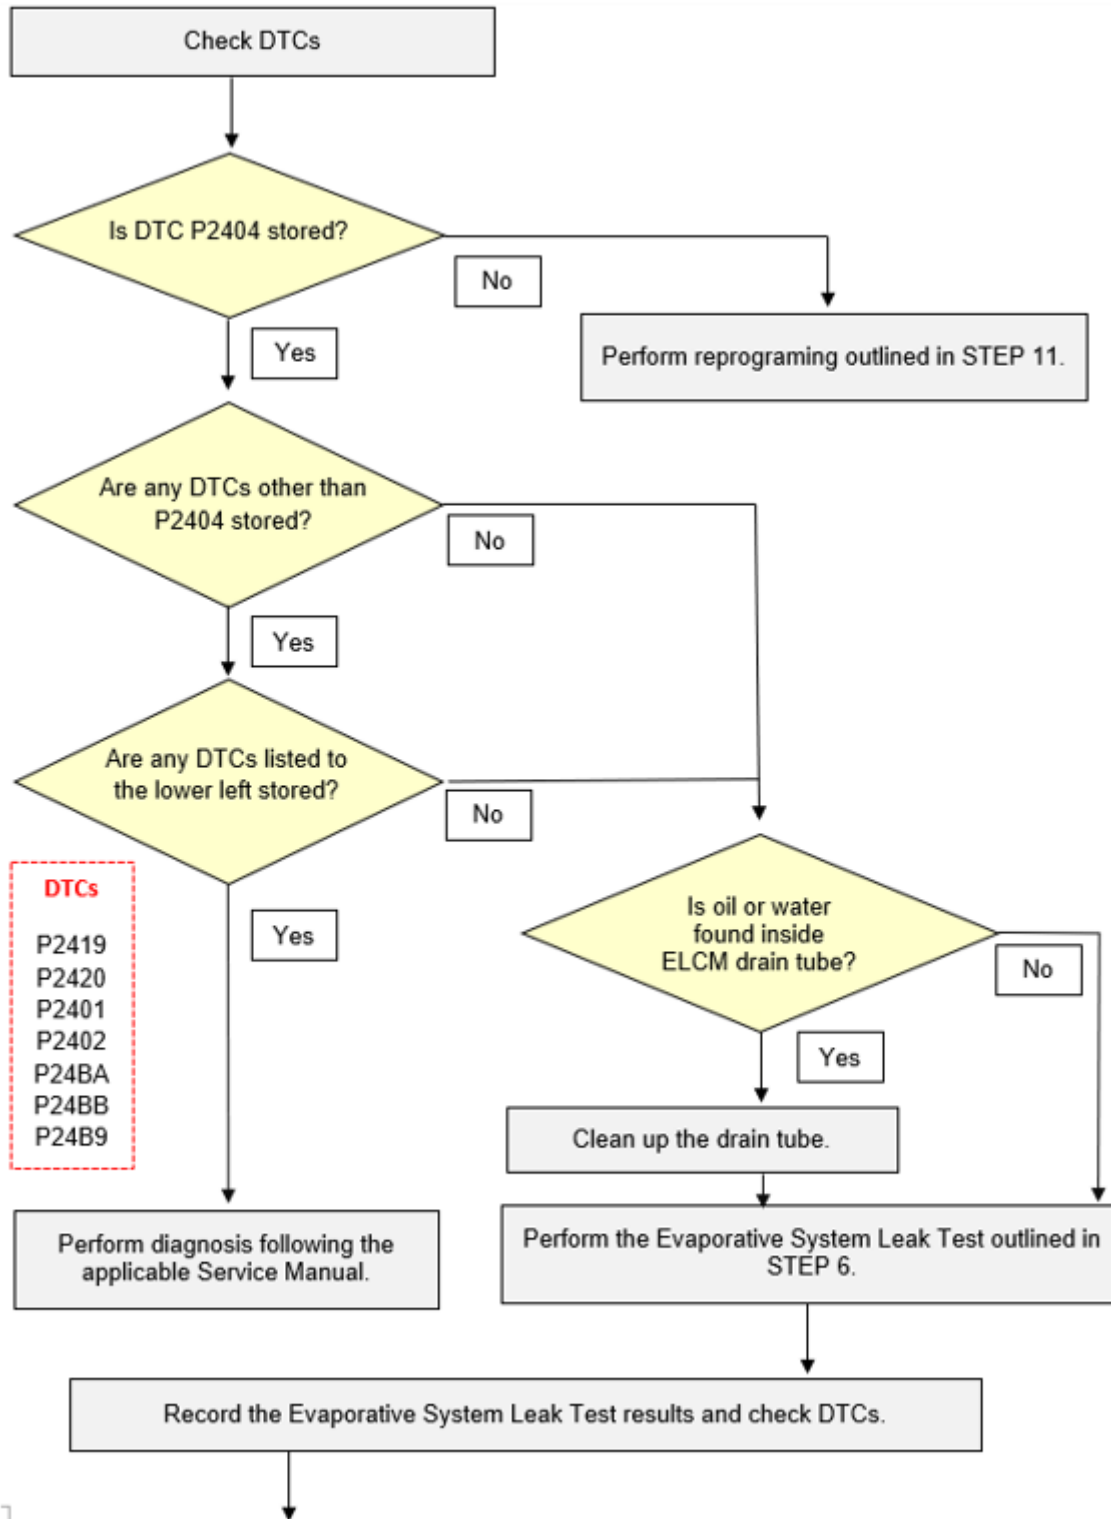
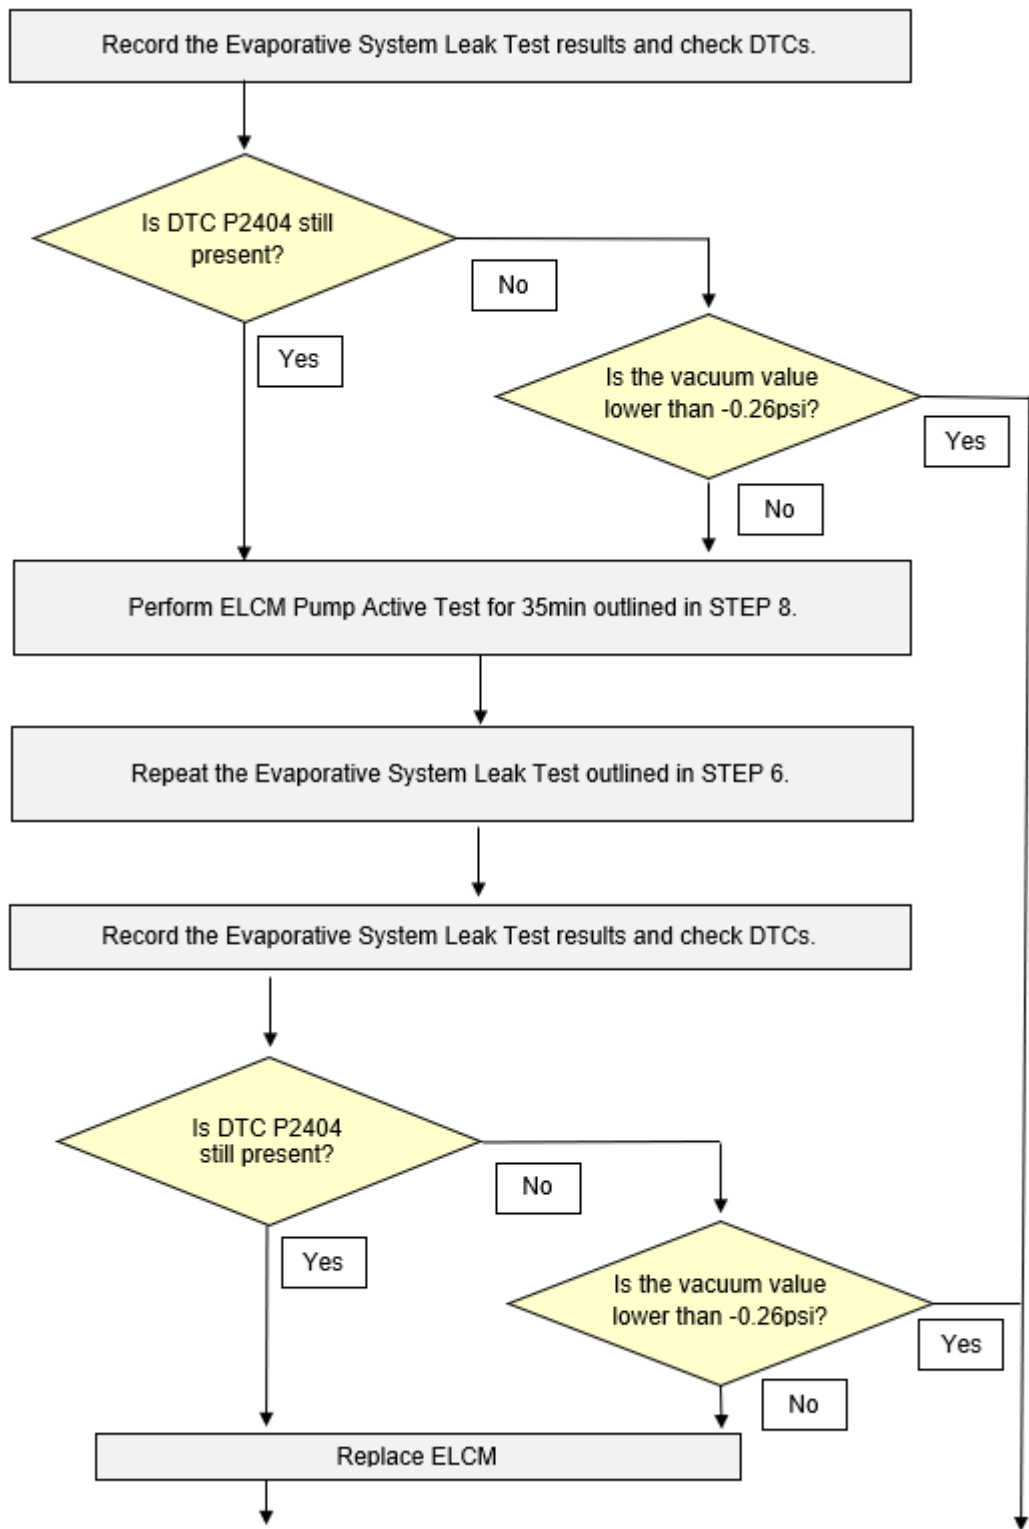
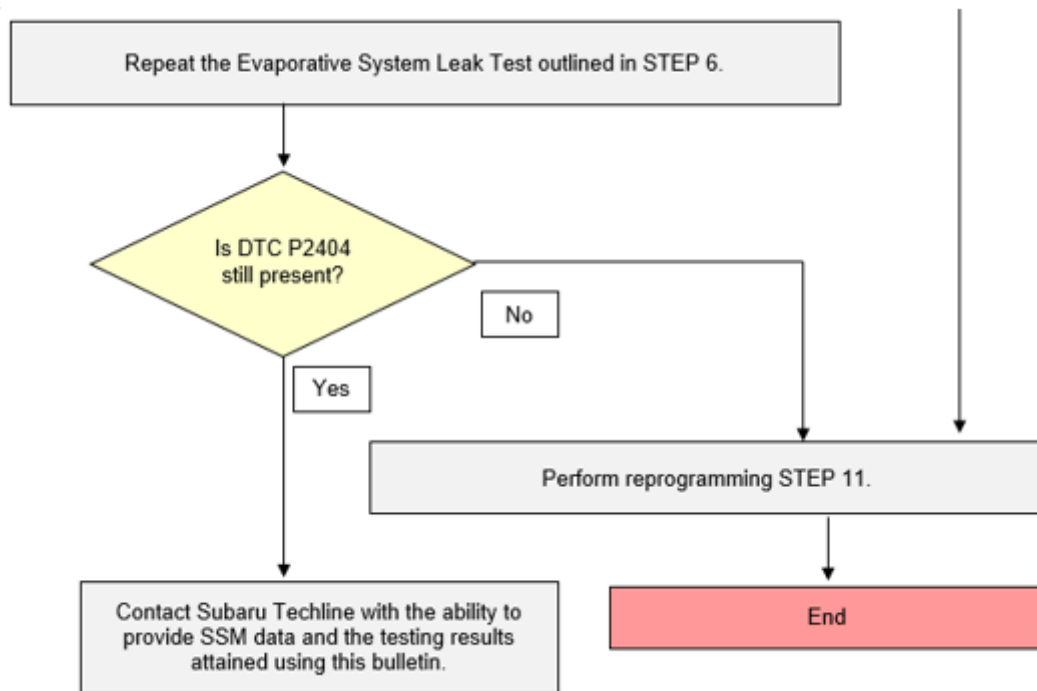
**SERVICE PROCEDURE FLOWCHART:**

This bulletin announces diagnostic procedures and availability of new Engine Control Module (ECM) reprogramming files to address DTC P2404 (Evap System Leak Detection Pump Sense Circuit Range/Performance) detection. In rare cases, the internal pump for the Evaporative Leak Check Module (ELCM) system can seize temporarily. The new files contain enhanced logic to prevent the ELCM pump from seizing. In addition, the logic further stabilizes the fuel pressure to reduce any hesitation during acceleration and prevent DTC P0087 detection. If P2404 and/or P0087 is found in the fault memory, follow the procedures outlined below.

**STEP 1:** Using Subaru Select Monitor (SSM), check for diagnostic trouble codes. Confirm P2404 is stored and proceed to the next step.

**STEP 2:** Are any of the diagnostic trouble codes listed below also stored with the ECM?

**STEP 6:** Connect the vehicle to a recommended power supply. See **APPENDIX A** for additional information regarding power supply. Using SSM, perform the Evaporative System Leak Test. Collect and save all data.

Once the evaporative system leak test is complete, check the DTCs and examine the vacuum value results. Record the value shown in the row labeled MID: \$3C, TID: \$C4, and Scaling ID: \$FE. This value should be lower than -0.26 PSI.

**STEP 7:** Was the vacuum value result observed in STEP 6 found to be lower than -0.26 PSI?

**NO** – Repeat the Evaporative System Leak Test (outlined in Step 6) then proceed to STEP 8.

Once the ELCM Pump Active Test has been performed for a period of 35 minutes or more, repeat the Evaporative System Leak Test outlined in STEP 6. Check the DTCs and the vacuum value results.

**STEP 9:** Was the vacuum value result observed during the second Evaporative System Leak Test found to be lower than -0.26 PSI?

**STEP 10:** Replace the Evaporate Leak Check Module and repeat the Evaporative System Leak Test outlined in STEP 6. Check the DTCs and the vacuum value results.
