SERVICE BULLETIN

APPLICABILITY: 2023-24MY Outback & Legacy
 2023-24MY Ascent
 2024MY Crosstrek/Impreza

NUMBER: 15-311-23R
DATE: 06/23/23
REVISED: 04/12/24

SUBJECT: FOTA (Firmware Over-The-Air) Reprogramming for DENSO Gen 4.5 Audio Navigation Infotainment Systems via DCM

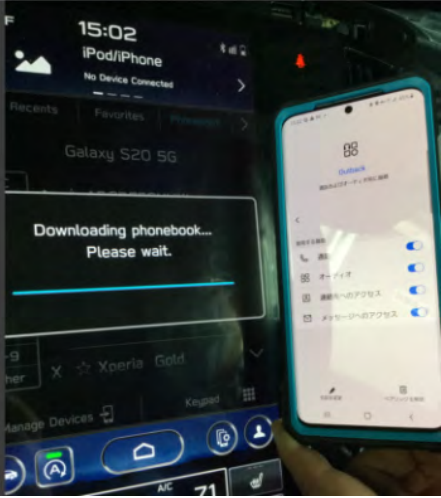
5	Phone	<p>After initiating the transfer of the phone's contacts from the smartphone, the transfer-in-progress screen may remain open and not automatically close even after the transfer has been completed.</p>

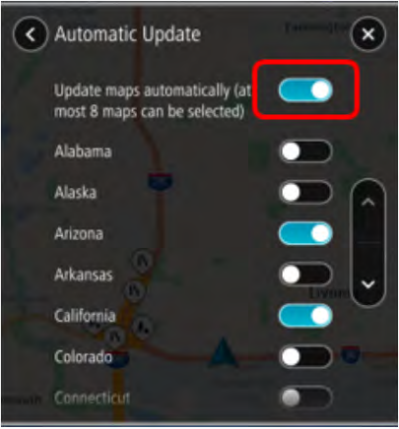
43	Phone	<p>While connecting an iPhone running iOS 16.4 to a vehicle, the SMS functionality cannot be used from the CID screen.</p>
44	Reset	<p>When turning ignition on/off repeatedly, the CID screen may restart after startup.</p>
45	Reset	<p>When the automatic map data update function is set to ON (as shown in the below screen,) the CID screen may restart after engine startup.</p>

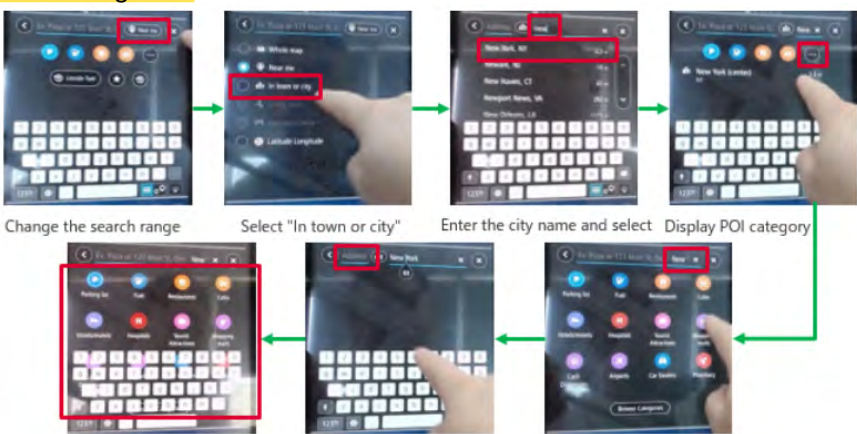
59	Navi	<p>Situation: Narrowing down the search range within a specific city in the navigation destination search. Move to the POI category screen.</p> <p>Touch the city name input area, then the keyword input area, in that order.</p> <p>Symptom: The text keyboard, which should not be displayed, appears on top of the list of POI categories.</p>

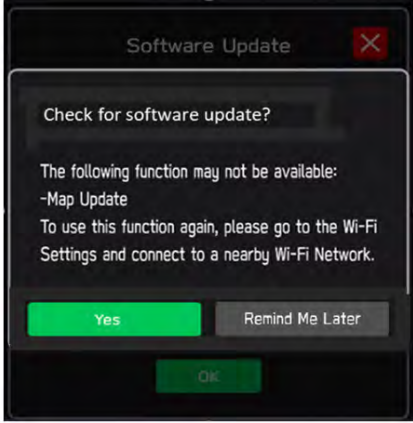
No	Category	Conditions/Symptoms to be improved
86	Reprogramming	<p>To use FOTA (Firmware update Over The Air) for CCU software update via DCM (Data Communication Module), it is necessary to switch from the Wi-Fi communication settings for MapUpdate to the DCM communication settings. To notify the customer about this switching, the below message screen pops up a new CCU software becomes available from the server.</p>

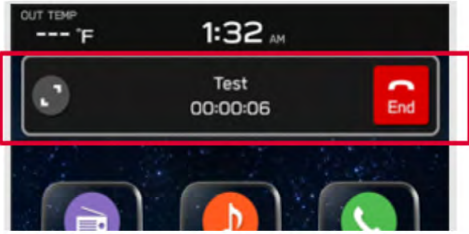
<p>Push "Search" button on the screen and "VR" button on the steering</p> <p>Only a popping sound is heard and it ends.</p>
94	Operation	<p>Situation: Displaying CarPlay call status in the Information Bar at the top of the CID during a call. Another popup overlaps on the Information Bar.</p> <p>Symptoms: Screen performance slows down, and touch operations become less responsive.</p>

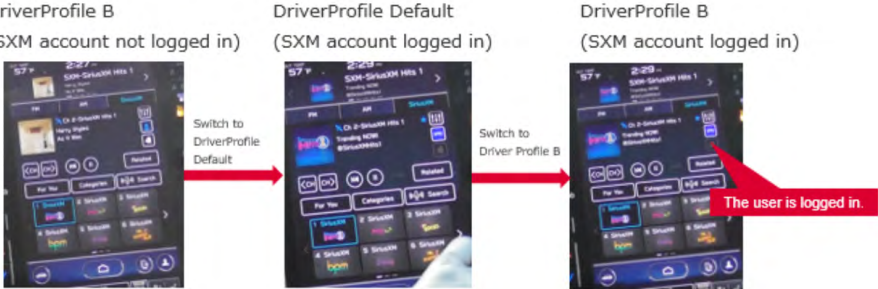
101	CarPlay	<p>CarPlay may disconnect when switching between CarPlay and other screens during CarPlay connection.</p>
102	Driver profile	<p>Switching the Driver Profile user causes the user to be logged into SXM even though he/she was not logged into the SXM account as the user after the switch.</p>

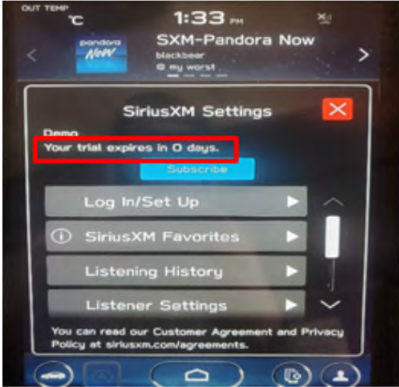
</div> </div>
105	SXM	<p>If the ignition-off/on operation is performed quickly immediately after ignition-on, the previously viewed channel in SXM may not start playing automatically. (It will play by switching the audio source).</p>
106	SXM	<p>When the contract status is Demo, "Your Trial Expires in 0 Days" is displayed on the SXM Seting screen. The display will be removed when the contract status is Demo.</p> <div style="text-align: center;">

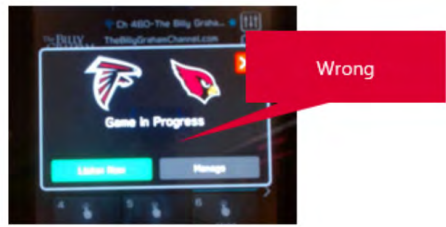
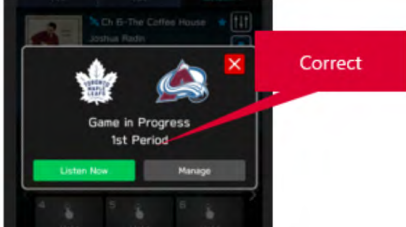
107	SXM	<p>Gametime (1st Period, etc.) is not displayed on the pop-up screen of SXM Sports channel when a game starts.</p> <div style="display: flex; justify-content: space-around;"> <div data-bbox="540 1608 982 1833">

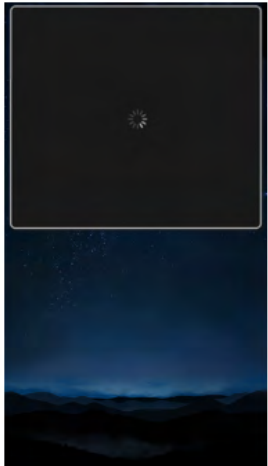
117	Black Screen	<p>After turning ignition ON, the "CAUTION" screen is displayed for 2 minutes. After the "CAUTION" screen is displayed, a reset may occur.</p>

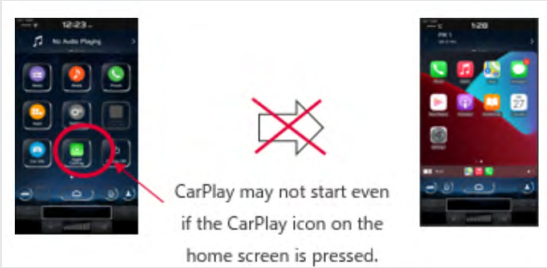
129	CarPlay	<p>When starting the engine with the iPhone connected via USB, CarPlay may not start even if the CarPlay icon on the home screen is pressed. (This can be resolved by reinserting the USB cable.)</p>
