Service Action

Code: 87H9

Subject	Pressure & Temperature Sensors																									
Document History	<table border="1"> <thead> <tr> <th>Date</th> <th>Summary</th> </tr> </thead> <tbody> <tr> <td>04/11/2024</td> <td>Updated claiming instructions</td> </tr> <tr> <td>02/23/2024</td> <td>Updated claiming instructions</td> </tr> <tr> <td>02/13/2024</td> <td>Original publication</td> </tr> </tbody> </table>	Date	Summary	04/11/2024	Updated claiming instructions	02/23/2024	Updated claiming instructions	02/13/2024	Original publication																	
Date	Summary																									
04/11/2024	Updated claiming instructions																									
02/23/2024	Updated claiming instructions																									
02/13/2024	Original publication																									
Affected Vehicles	<table border="1"> <thead> <tr> <th>Country</th> <th>Beginning Model Year</th> <th>Ending Model Year</th> <th>Vehicle</th> <th>Vehicle Count</th> </tr> </thead> <tbody> <tr> <td>USA</td> <td>2021</td> <td>2022</td> <td>E-TRON QUATTRO</td> <td>7,387</td> </tr> <tr> <td>USA</td> <td>2020</td> <td>2022</td> <td>E-TRON SPORTBACK QUATTRO</td> <td>3,307</td> </tr> <tr> <td>CAN</td> <td>2021</td> <td>

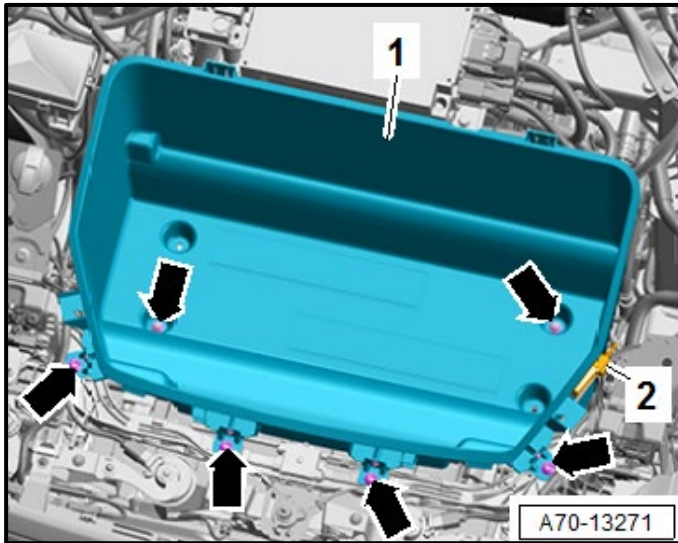
Section B – Sensor Inspection

Inspect G395 and G826 pressure/temperature sensors:

- Remove front luggage compartment liner <1> per the ELSA repair manual:
 - *Repair manual > Body > Body Interior > Interior Trim > Luggage Compartment Trim Panels > Front Luggage Compartment Liner, Removing and Installing*
