Service Bulletin

Bulletin No.: 22-NA-237

Subject: Service Cluster Message and DTC U3000 Set

Brand:	Model:	Model Year:		VIN:		Engine:	Transmission:
		from	to	from	to		
Buick	Envision	2022	2023

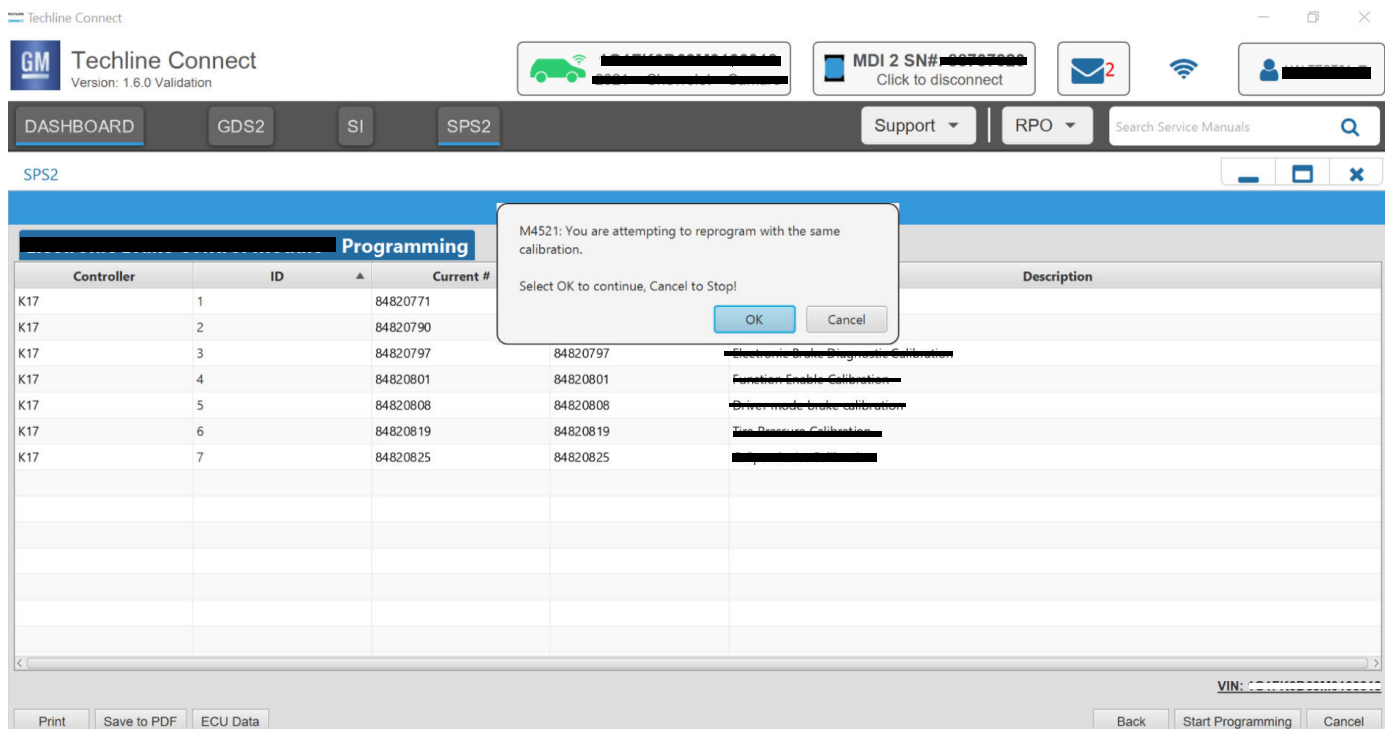
5877000

Important: Techline Connect and TIS2WEB screens shown above.

Important: If the same calibration/software warning is noted on the TLC or SPS Summary screen, select OK and follow screen instructions. After a successful programming event, the WCC is located in the Service Programming System dialogue box of the SPS Summary screen. No further action is required. Refer to the Warranty section of the bulletin.
