2015-2019MY  
Soul EV (PS EV)

SC267Z (Rev 1, 05/07/2024)

## SUBSEQUENT REPAIR ACTION

HIGH-VOLTAGE BATTERY PACK ASSEMBLY  
REPLACEMENT (SC267Z)

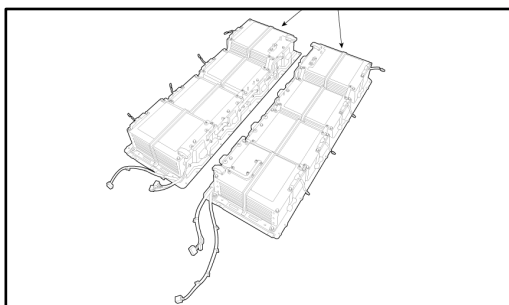
This bulletin provides information to replace the high-voltage battery pack assembly (HV BPA) on certain 2015-2019MY Soul EV (PS EV) vehicles produced from July 15, 2014 through September 28, 2018. After completing SC267 with the latest battery management system (BMS) software upgrade, the subject vehicles may subsequently require the replacement of the HV BPA due to MIL ON with a BPA related DTC(s). Follow the procedure outlined in this publication to scan the vehicle for related DTC(s) and replace the HV BPA, if applicable. Before conducting the procedure, verify that the vehicle is included in the list of affected VINs.
