CADILLAC
DCS6893
URGENT - DISTRIBUTE IMMEDIATELY

Subject: UPDATE: N232428540 - Customer Satisfaction Program
Multiple Module Reprogramming
Population Expansion

Models: 2023 Cadillac LYRIQ

N232428540 Multiple Module Reprogramming

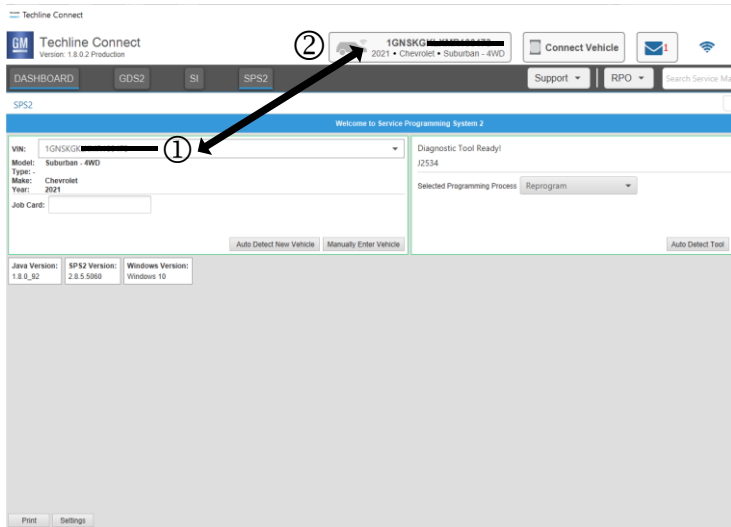
5743643

Caution: Be sure the VIN selected in the drop down menu (1) is the same as the vehicle connected (2) before beginning programming.

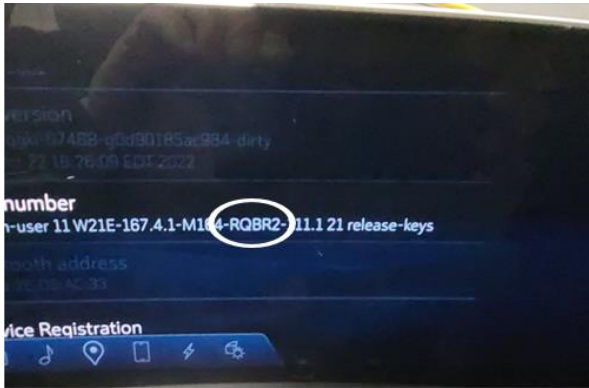
6554765

1. Ignition On, verify the build number:

5.1. If the build number is W37E-169.1.2-M164-RQBR2-198.1. continue to step 2. **RQBR2 is what should be verified.**

5.2. If the build number is 170.5.1-M166-SQBR3-187.1 continue to step 20.

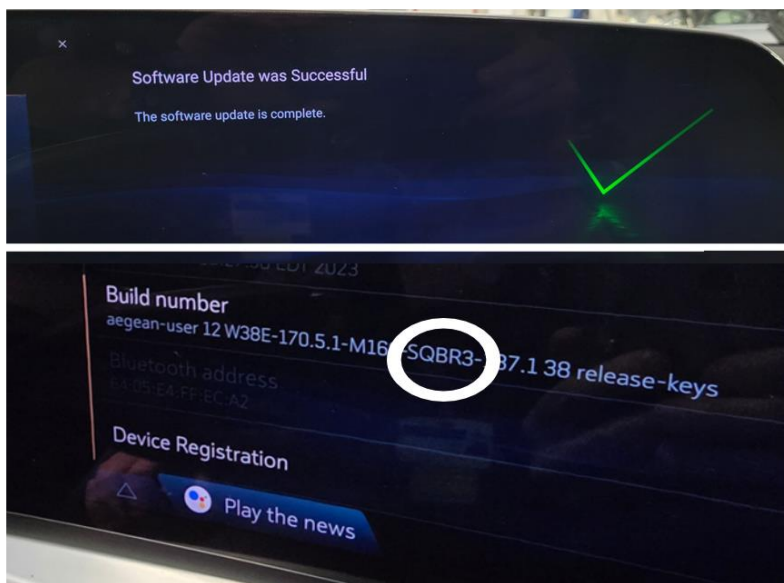
6554770

20. Ignition On, verify the build number is 170.5.1-M166-**SQBR3**-187.1. **SQBR3** is what should be verified. If build number displays 170.5.1-M166-**SQBR3-187.1**, continue to step 22.
21. If the radio does NOT display 170.5.1-M166-**SQBR3-187.1** please go back to step one and go through the update and programming process again.
22. Ignition Off.
23. Connect a USB drive to the computer.
