# Service Bulletin

Bulletin No.: 23-NA-115

**Subject:** Ticking, Tapping or Snapping Noise from Engine - 5.5L RPO LT6 Realign Camshaft Caps as Required

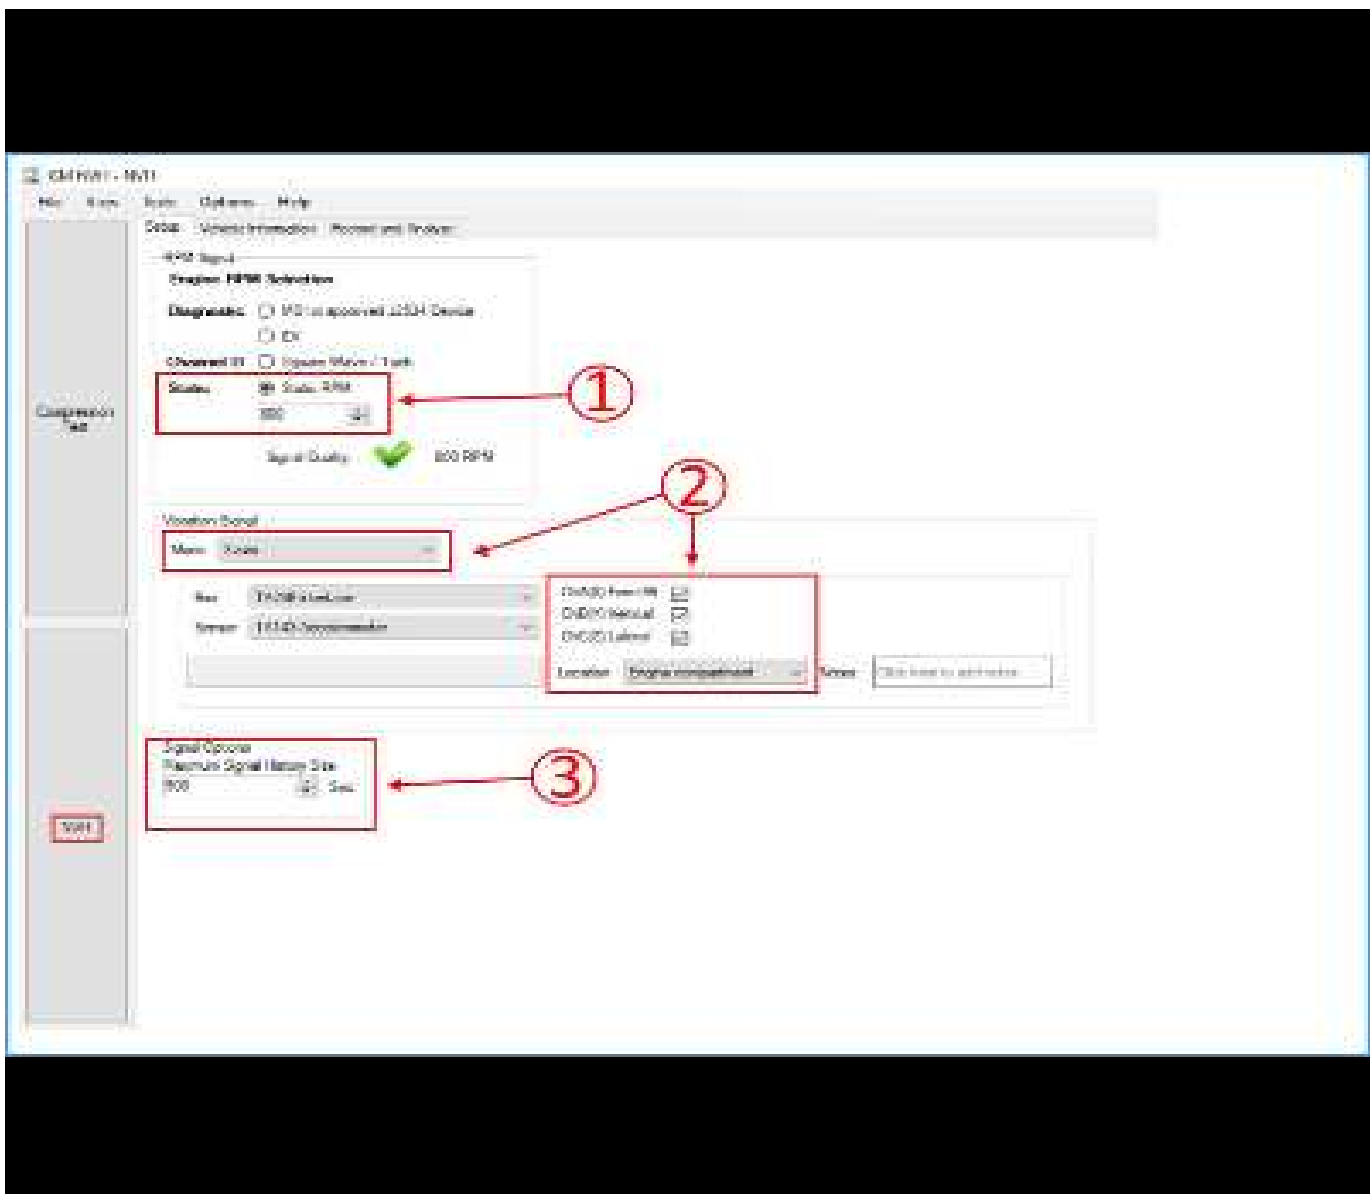
6374911

1. Open the GM NVH software and click on the NVH button.

2. Start a new test with the setup wizard:
  - ⇒ 1) Under RPM Signal – Ensure Static RPM is set to 800 RPM.
  - ⇒ 2) Under Vibration Signal – Select three-axis mode then ensure all 3 channels are checked and the location is set to Engine Compartment.
  - ⇒ 3) Under Signal Options – Set the Maximum Signal History Size to 500 seconds.
3. Go to the setup screen to finalize the wizard setup.
