Subject: REVISION: N242436241-02 – Customer Satisfaction Program  
Multiple Module Reprogramming  
Revised Service Procedure

Models: 2024 Chevrolet Blazer EV

## N242436241 Multiple Module Reprogramming

**Revision:** 02

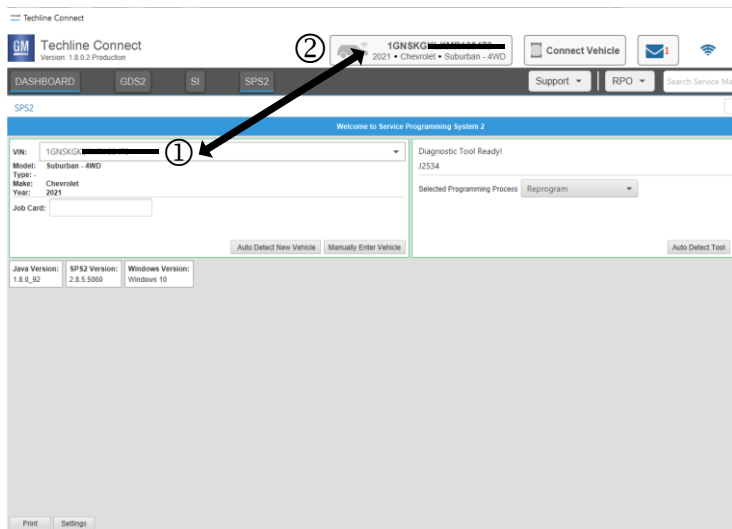
5743643

**Caution:** Be sure the VIN selected in the drop down menu (1) is the same as the vehicle connected (2) before beginning programming.

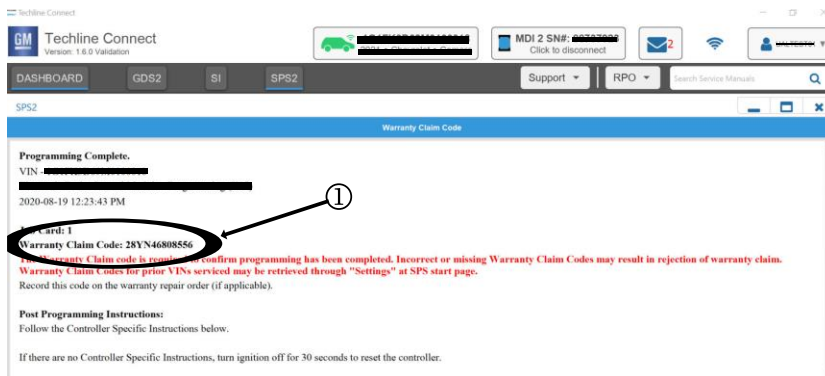
5644478

**Note:** The screenshot above is an example of module programming and may not be indicative of the specific module that is being programmed. Module selection and VIN information have been blacked out.

1. Restart Techline Connect.
2. Reprogram all equipped modules shown in the “Select Controller” section of SPS2 in Techline Connect. Refer to *Diagnostic Overview, Starting Point, and Programming> Programming and Setup> Repair Instructions* in SI for the applicable modules being reprogrammed.
3. If the front view camera module is reprogrammed, the front view camera module **MUST** be calibrated. Refer to *Front View Camera - Windshield Learn* in SI.
