GENERAL MOTORS
DCS6889
URGENT - DISTRIBUTE IMMEDIATELY

Subject: N232434060 - Service Update
Power Tonneau Cover Motor

Models: 2022-2024 GMC HUMMER EV Pickup
Equipped with ACCESSORY-TONNEAU (RPO 5KM)

N232434060 Power Tonneau Cover Motor

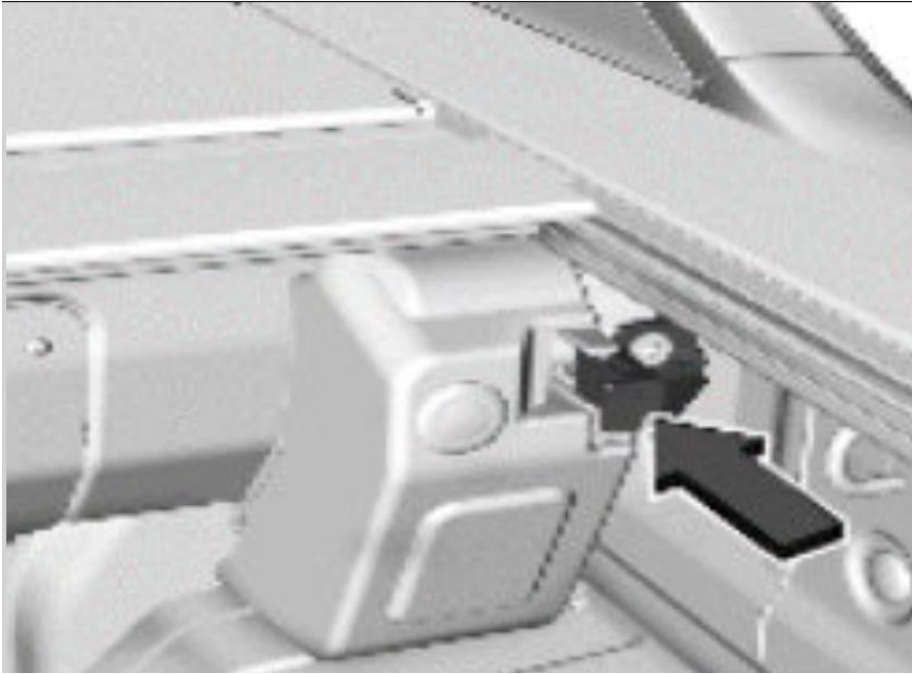
6325300

- If the Power Tonneau Cover does not operate, **push** the motor clutch button located at right side of the canister to disengage the motor, then push the cover slats forward.

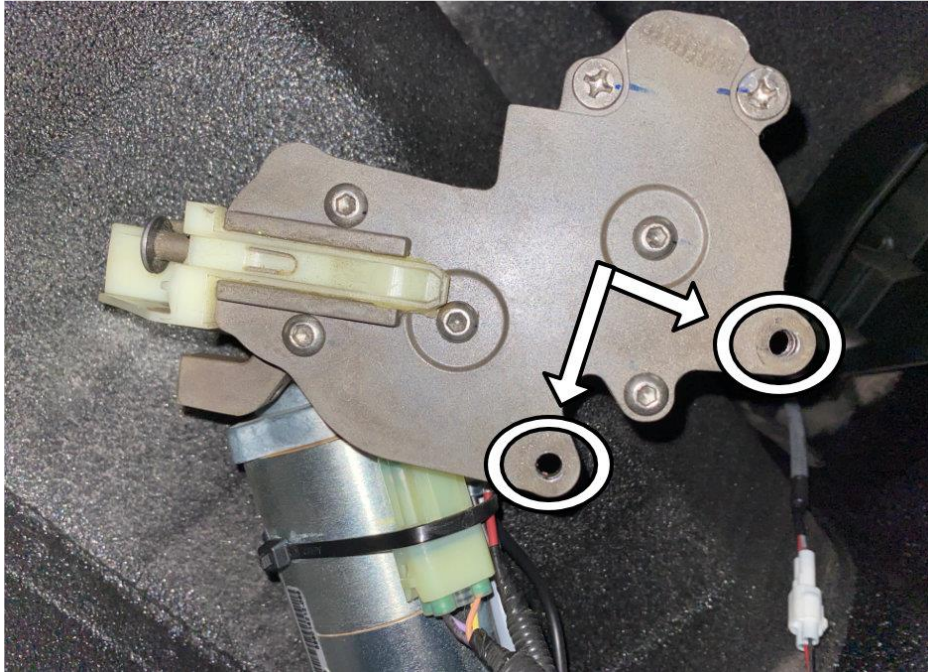
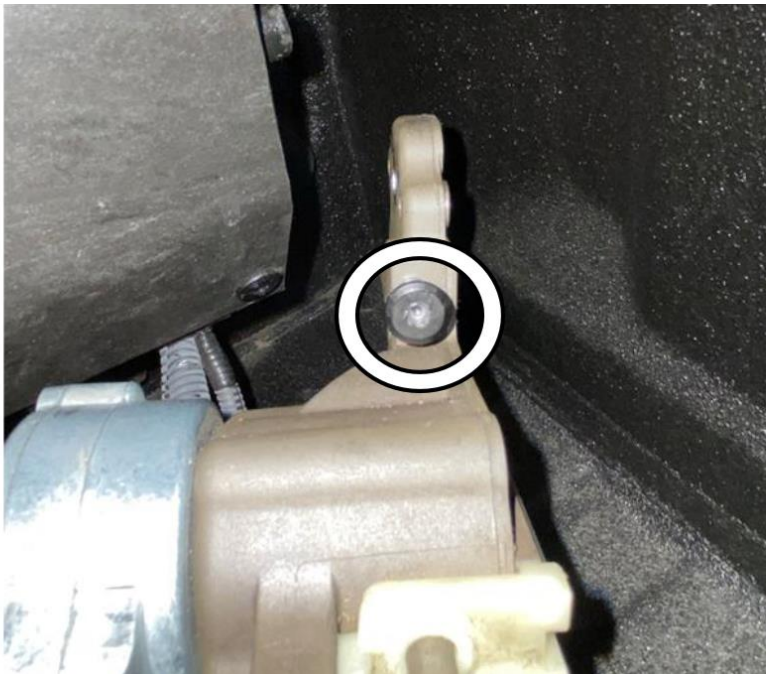
6. Inspect the Power Tonneau Cover Motor for damage such as leakage or any visible brown substance on the motor.
 - If the Power Tonneau Cover Motor IS NOT damaged, proceed to Step 11.
 - If the Power Tonneau Cover Motor IS damaged, proceed to Step 7.
