Service Bulletin

Bulletin No.: 22-NA-173

Subject: Information on Transmission Fluid Leak

Brand:	Model:	Model Year:		VIN:		Engine:	Transmission:
		from	to	from	to		
Chevrolet	Corvette	2020	2024	—	—	All	All

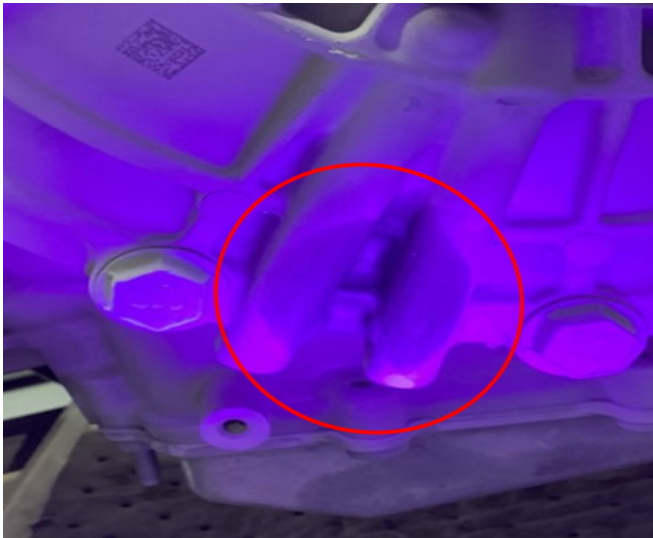
6142818

Porosity concerns with the differential cover. This area needs to be carefully powder tested to verify the leak is not associated with the cover seal (16) or the dog-bones and seals. Technicians have stated that they have found the cover double-gasketed when they confused the metal differential shims with what they thought were gaskets. All shims need to be re-installed to retain proper bearing load on differential. If porosity is found in the cover, the transmission will require replacement.

Note: Due to a revision in service information, the engine cradle no longer needs to be removed to replace the auxiliary canister filter housing. This led to an update in the labor time study and the labor hours for this repair have been adjusted to reflect this.

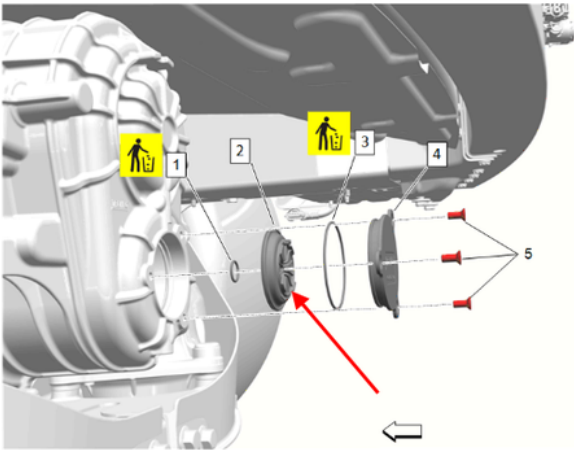
6637446

Transmission rear cover area leak. (Tremec name plate):

- If there seems to be a leak in this area, be sure to clean the area thoroughly. Residual oil can get trapped between the outer surface and the O-ring.
- After powder testing, if a leak re-occurs, remove the cover, and inspect the O-ring for damage.
- If no obvious damage is found with the O-ring, be sure to inspect the cover itself for porosity issues in the O-ring groove. It is critical to identify the difference between a leak and dampness.

- The red arrow in the graphic above, points to the oil dam that may come off when the cover (Tremec name plate) is removed. If it is removed, it is necessary to replace the associated O-ring and align properly with cover prior to re-assembly. Damage will occur if the oil dam is not aligned to match the cover.
