Subject: WATER PUMP COOLANT LEAK	Service Alert No.: SA-035/24
	Last Issued : 05/31/2024

APPLICABLE MODEL(S)/VINS

2018-2021 CX-3
2020-2025 CX-30
2018-2025 CX-5
2023-2025 CX-50
2025 CX-70
2018-2023 CX-9
2024-2025 CX-90
2018-2025 Mazda3
2018-2021 Mazda6
2018-2025 MX-5

DESCRIPTION

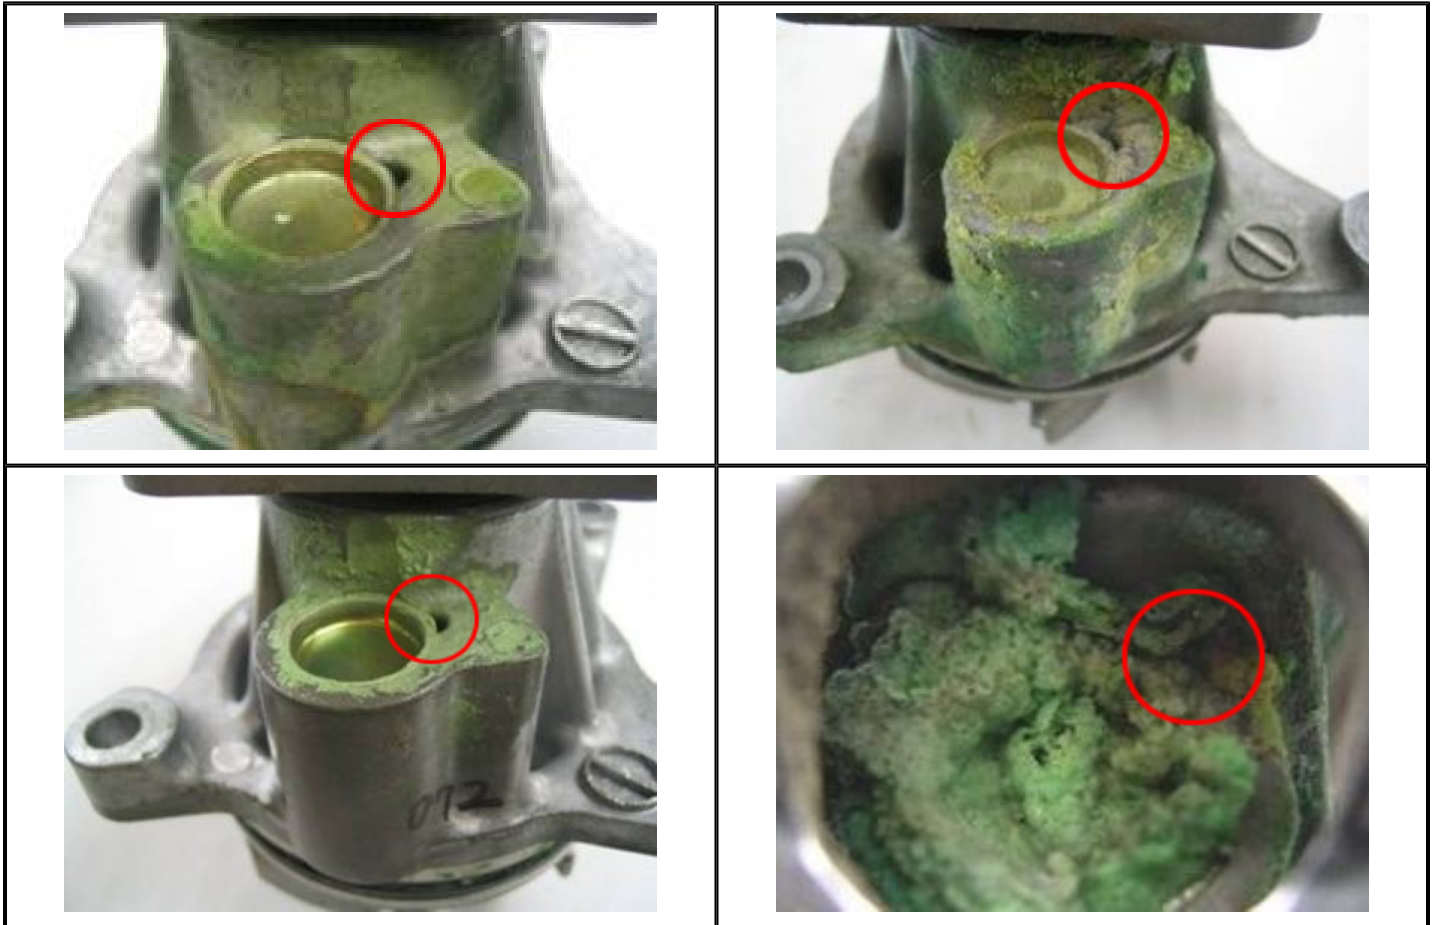
Water Pump Samples:	
<p>GOOD</p> <p>No accumulation of crystallized coolant near the bleed hole (F).</p> <p>DO NOT replace the water pump.</p>	<p>NO GOOD</p> <p>Accumulation of crystallized coolant near the bleed hole (F)</p> <p>REPLACE the water pump.</p>
