Technical Service Bulletin

GROUP CAMPAIGN	NUMBER 24-01-019H
DATE MAY 2024	MODEL(S) IONIQ 5 (NE1)

SUBJECT: TMK SEALANT LEAKAGE INSPECTION/PARTS REPLACEMENT
(SERVICE CAMPAIGN TBM)

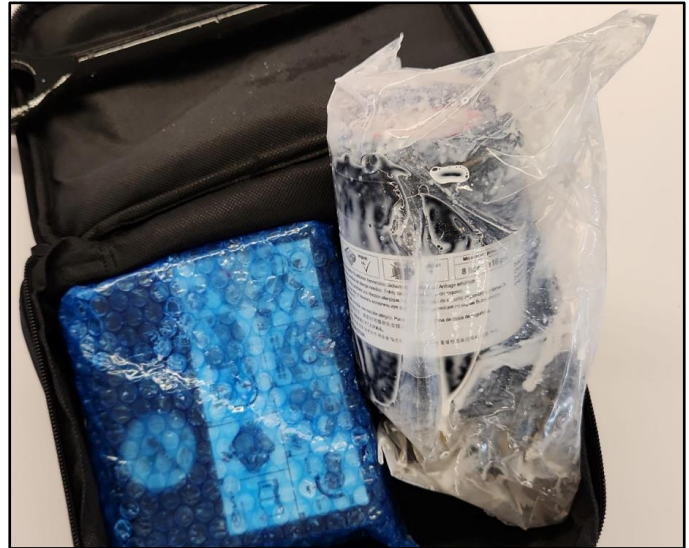
4. Open the TMK bag to inspect for sealant leakage.

If no sealant leakage is found, proceed to [TMK Sealant Cap Replacement](#) on page 6.
