# 42–080 ABS Wheel Speed Fault Code Correction for MBSP Equipped Vehicles

## TSB-42-080-FTL

► New Cascadia

### Described Condition

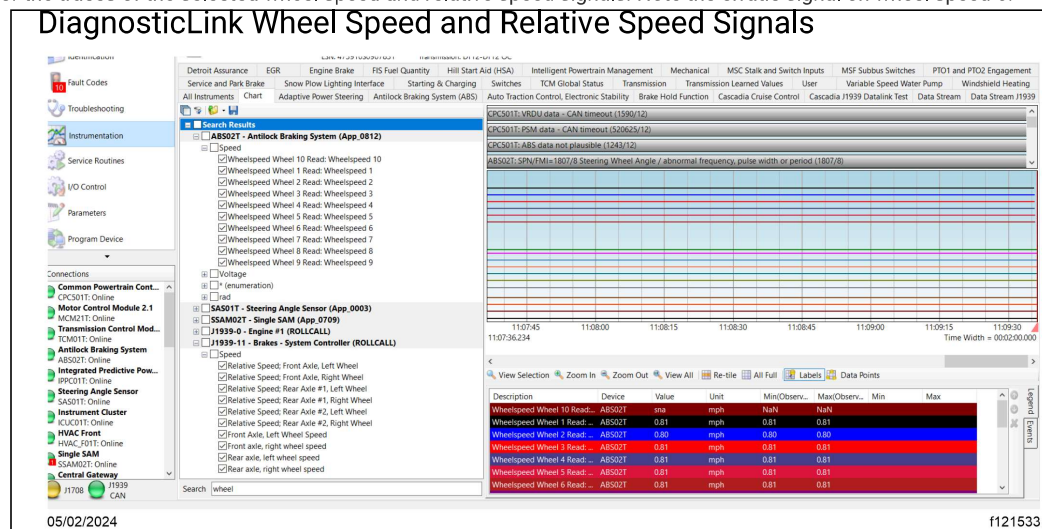
Fig. 1, DiagnosticLink Wheel Speed and Relative Speed Signals

13. ☐ During the test drive, monitor the wheel speeds using DiagnosticLink and ensure that the ABS module and all J1939 connections are active. Do the wheel speeds appear erratic, spike up, or show readings when the vehicle is stationary? It is recommended to refer to the chart instead of the ABS tab/panel. See Table. [Wheel Speed Chart Signals 3](#) and Fig. 1 for the charting selections in DiagnosticLink.
