Service Bulletin

Bulletin No.: 18-NA-020

Subject: Poor Engine Performance in Extremely Cold Weather Conditions, Malfunction Indicator Lamp (MIL) Illuminated with DTCs P0300, P0299, P0234 and/or P2227 Set

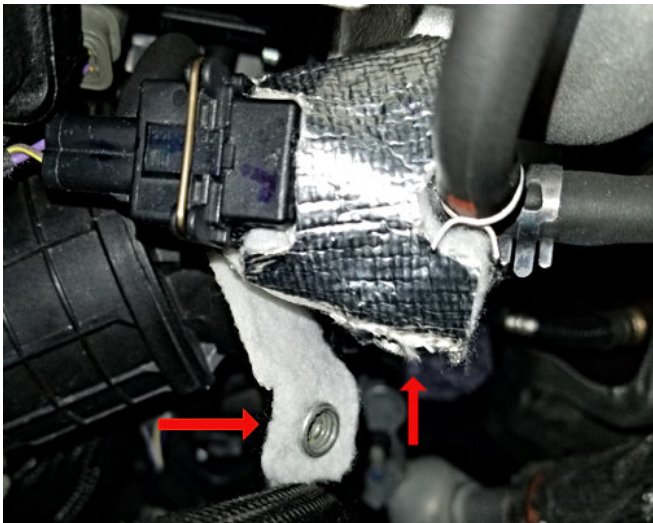
6055084

- This is an off-car view of the wrap installed on the TCV and is representative of what final installation should look like. The snap can NOT be completed prior to installing the mounting bolt
5. Reinstall Turbocharger Wastegate Solenoid Valve (TCV) using the latest service information.

6. Once the mounting bolt and hoses are properly installed, pull the lower portion of the wrap upward, and snap it into position
7. Clear all DTC's using GDS and evaluate
8. Continue to Part 2.
