HYUNDAI
Technical Service Bulletin

GROUP BODY ELECTRICAL	NUMBER 24-BE-007H
DATE JUNE 2024	MODEL(S) SANTA FE (MX5A)

SUBJECT: COAXIAL CABLE SHIELD ADJUSTMENT FOR DISPLAY SCREEN FLICKERING/BLANK

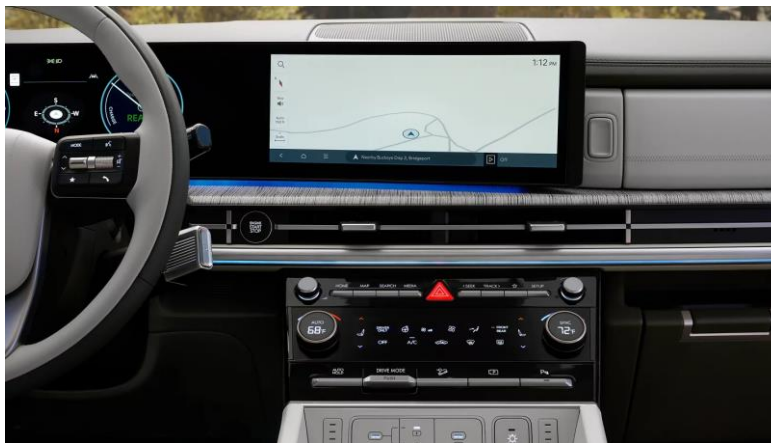
Description: Certain 2024MY Santa Fe (MX5A) vehicles may exhibit a display screen flickering or intermittently going blank. This may be due to the shield width of the coaxial cable being too wide, causing a loose connection. Follow the procedures in this bulletin to adjust the width of the shield using a supplied shield adjustment jig.

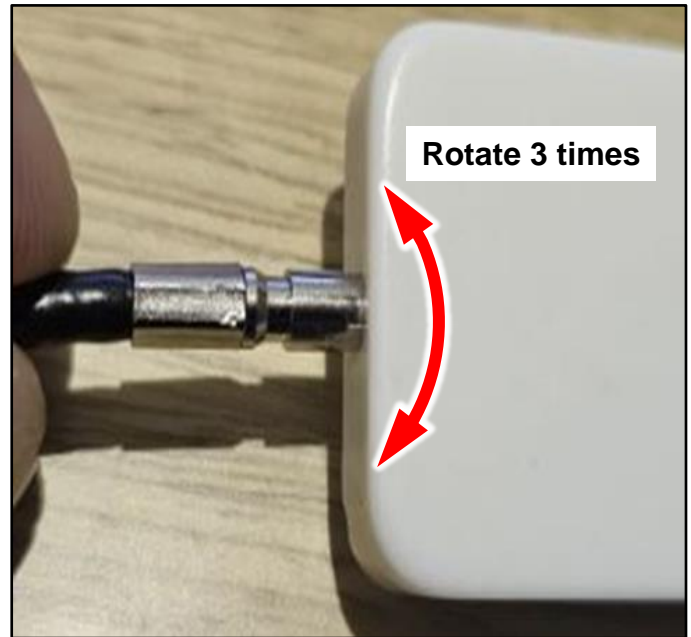
This will reduce the width of the shield to enable a better connection in the connector.

- Once inserted, rotate the jig around the shield 3 times.

- Remove jig for use in next affected vehicle.
