## SERVICE BULLETIN

**APPLICABILITY:** 2017-22MY Impreza  
 2018-23MY Crosstrek  
 2019-23MY Forester  
 2022MY WRX

**NUMBER:** 07-221-23R

**SUBJECT:** Instrument Panel Wiring Harness & Rear Wiring Harness – Connector Corrosion

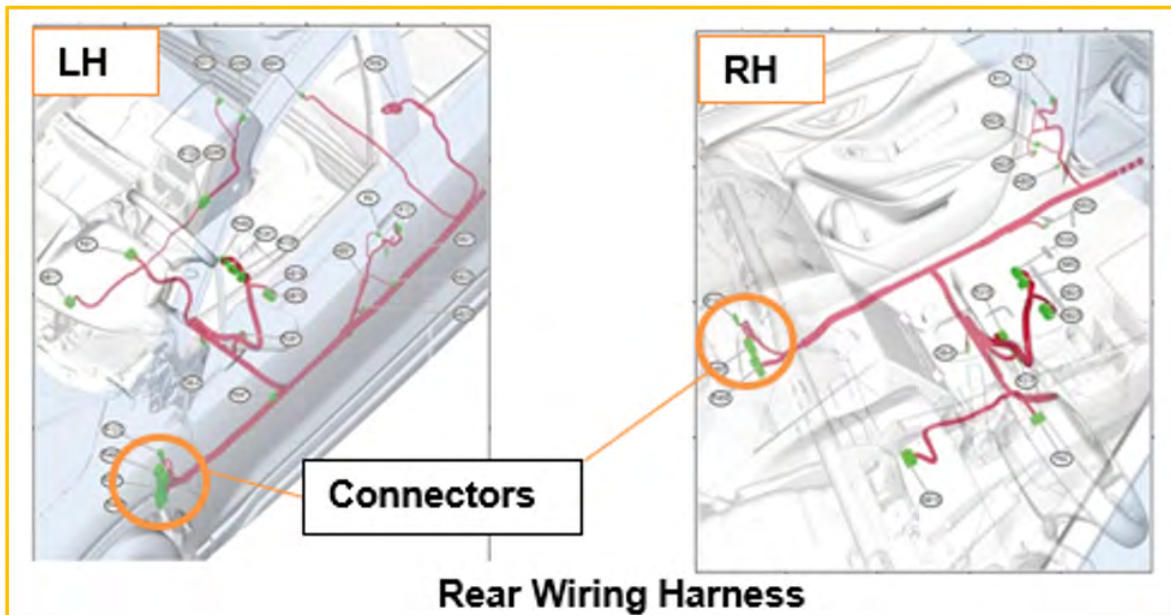
**WIRING HARNESS DETAIL INFORMATION:**

This bulletin announces the repair procedures when corrosion is encountered within the instrument panel wiring harness and the rear wiring harness connectors. The corrosion is typically found in the footwell area as a result from moisture such as rain, snow, ice, and salt water being brought in from driver and/or passenger footwear. Corrosion in this area can cause multiple electrical malfunctions such as warning indicators and/or incorrect door position detection. If corrosion is found within this area(s), replace the affected wiring harness and perform the added procedure detailed below using the new repair kit. The purpose of the repair kit is to isolate the connections from any moisture damage.
