All Vehicles Equipped with M139: CEL for P012800 - The coolant temperature is below the coolant thermostat specified temperature.

| Topic number | LI20.10-P-076206 |
| Function group | 20.10 - Coolant pump, coolant thermostat |
| Validity | All vehicles with any version of M139 engine |

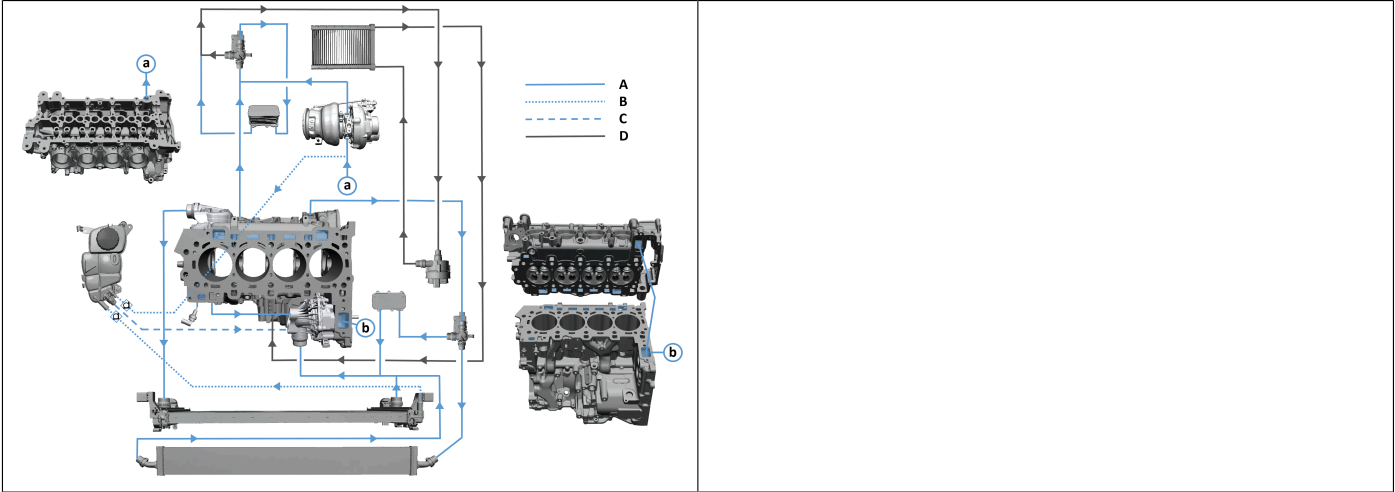
[CLA\\_GLA M139 Coolant Diagram.png](#)

Debris in the coolant system

- Remove and replace the coolant expansion tank (reservoir) and the main radiator.
- Without removing the components: flush the heater core and changeover valve (located in the right front wheel arch) in the opposite direction of flow until no debris remains.
