Technical product information

Topic	Rear screen sunblind operational issues
Market area	Bentley: worldwide (2WBE)
Brand	Bentley
Transaction No.	2070643/5
Level	EH
Status	Approval
Release date

New Flying Spur

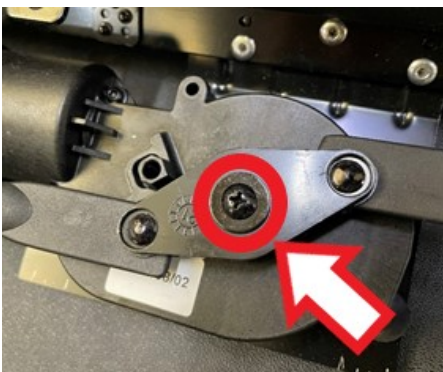
- Referring to Figure 8 - Remove the rotator plate fixing (2.5Nm)
- Then remove the rotator plate

In the event the rotator plate is NOT OK as shown in the examples in Figure 9 and Figure 10, the operative should replace the rear blind assembly

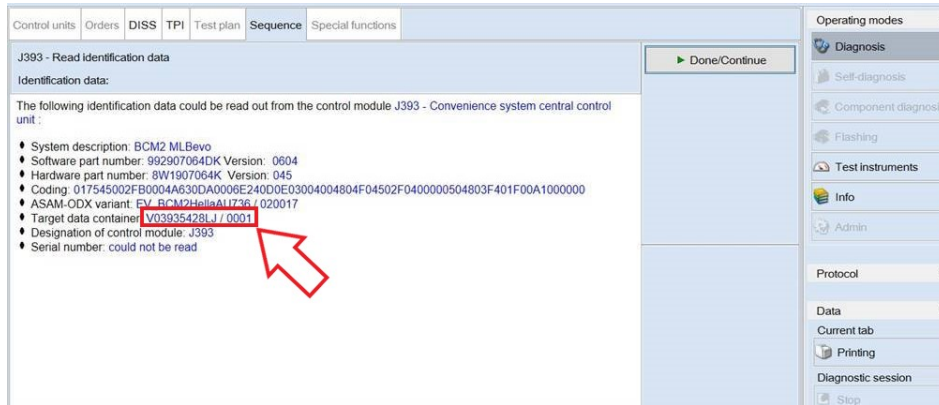
Figure 12

Should the software version be ZDC V03.935.428.LJ (Figure 12) the software is at the latest level the operative should refit the rear parcel shelf as Rep.Gr 70
