Field campaign

| Topic | Software update to 0042 / 07D2 (Driver door control module) and 0052 / 07D3 (Passenger door control module) - SC24/16 |
| Campaign number | ED09 |

Bentayga Extended Wheel Base

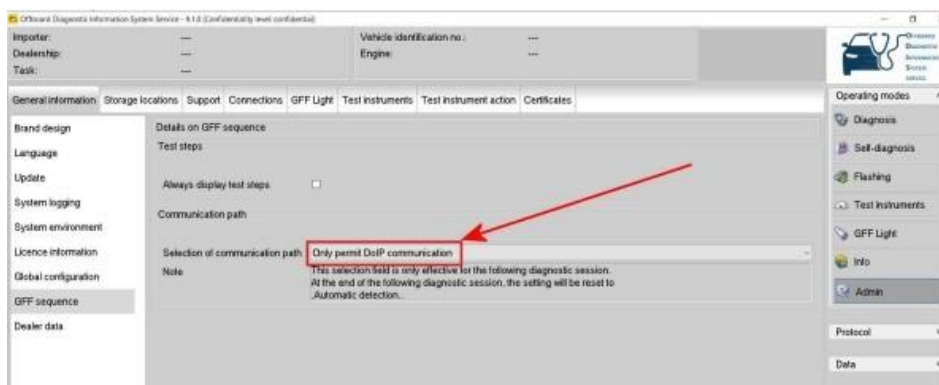
Figure 5

VERY IMPORTANT: Before conducting the onward instructions / entering the SVM code, the operative MUST recheck the DoIP set up in ODIS and ensure that DoIP is selected (Figure 5) before proceeding

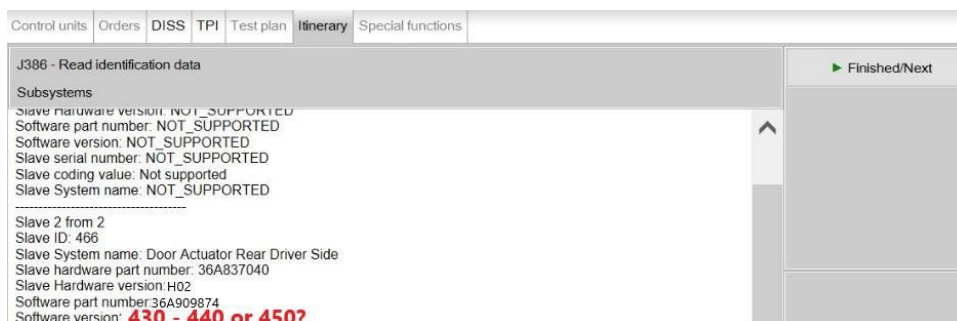
- 1) Select and run Guided Fault Finding
- 2) Referring to the example shown in Figure 6 - Navigate to the front driver door module (0042 / J386) > Guided Functions > Read identification data
 - Repeat for the front passenger door module (0052 / J387)

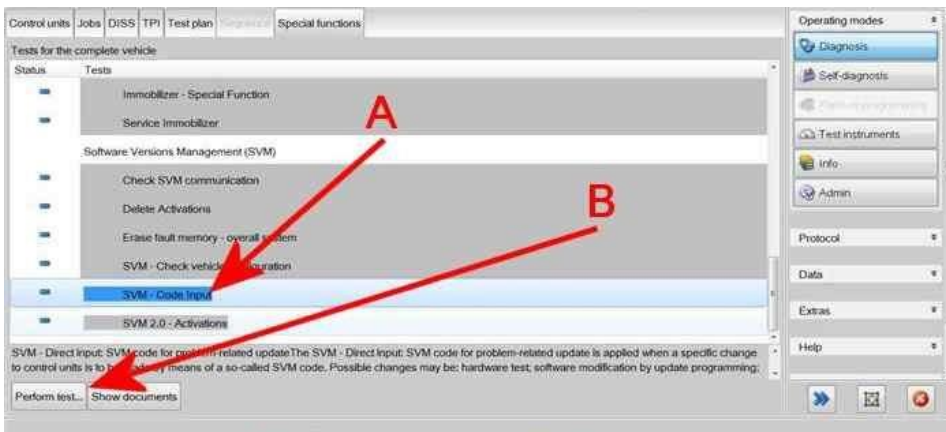
3) Referring to Figure 7 - Within the Special functions tab select SVM - Code Input (A) then select Perform test (B)

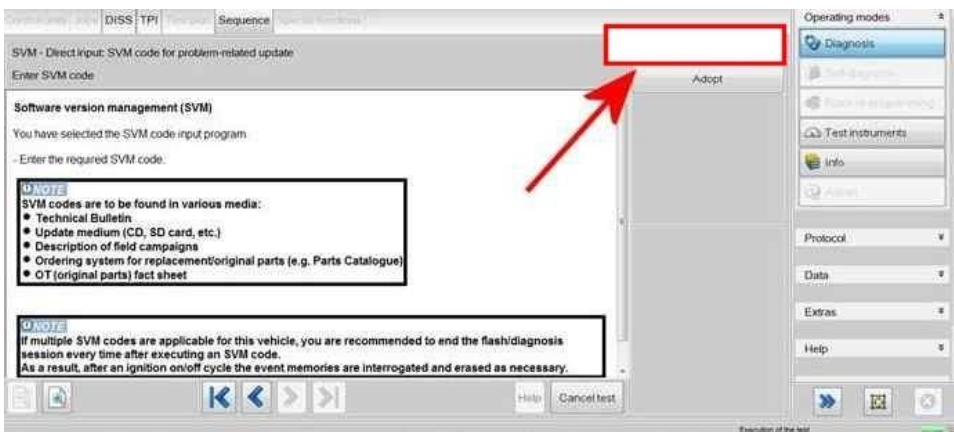
Figure 8

4) On the next screen enter SVM code **4V1BIL53** and select Adopt (Figure 8)

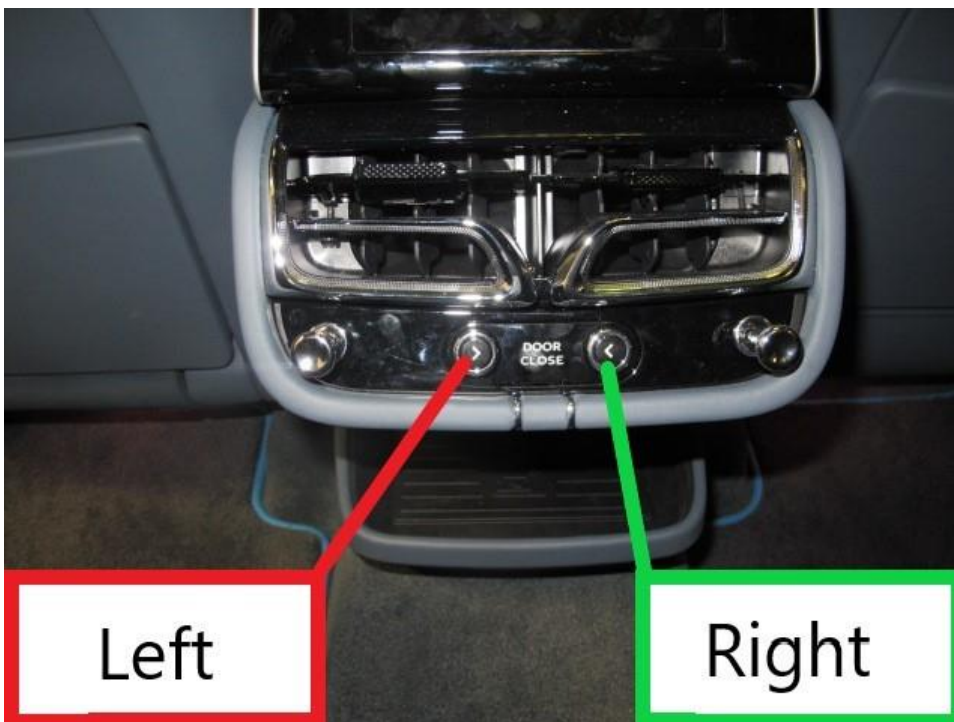
- **The RHF - LHF and RHR doors must all be closed**
- **The tailgate must be closed**
- **All windows must be closed**
- Referring to Figure 9 - Press and hold the left DOOR CLOSE button

- Check the LHR door fully closes and latches (including soft close operation) without the requirement to press the button a second time
- Once fully closed/latched - Fully reopen the LHR door
- Repeat the power close operation (x2) times (x3 in total)

In the event the door close / latch operation fails at any point the operative must raise a DISS query and await feedback before conducting any further work
