Service Bulletin

Bulletin No.: 23-NA-107

Subject: Roof Related Water Leak, Shifter Light Inoperative, Key Fob Inoperative and/or Various Remote Control Door Lock Receiver (RCDLR) Concerns

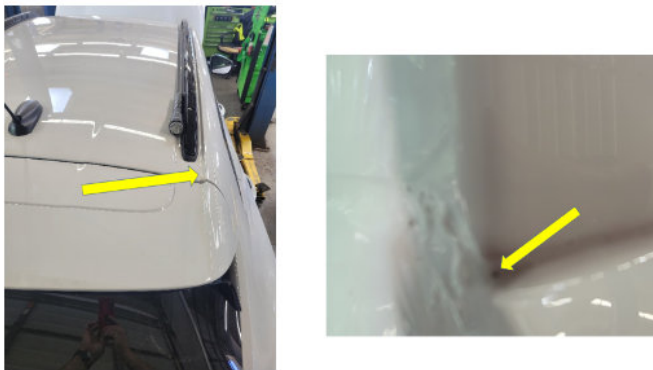
6370899

The cause of the condition may be a pin hole / poor sealing in the roof body seam or poor brazing weld. This condition could occur at either the front and/or rear, and on the right and/or left side or cross rail front stud not sealing to body of the vehicle. ⁶⁵⁰¹²⁵³

Inspect and repair water leak as necessary.

1. Visually inspect the front right and left roof laser braze, then the rear right and left roof laser braze, for pin holes or a crack.

2. Seal the holes/crack in any laser braze area following the steps below:
 - 2.1. Mix a small amount of Kent® High-Tech Seam Sealer Clear P10200, or Wurth Euroseal Gel Clear 18920104, or equivalent WITH the proper touch-up paint color.
 - 2.2. Avoiding excess sealer build-up within the ditch, work a small amount of the sealer into the hole with a gloved finger.
