**TECHNICAL INSTRUCTIONS  
FOR  
SPECIAL SERVICE CAMPAIGN  
24TD03  
INFOTAINMENT “SERVICE” SUBMENU IS NOT VISIBLE  
CERTAIN 2022 MIRAI VEHICLES**

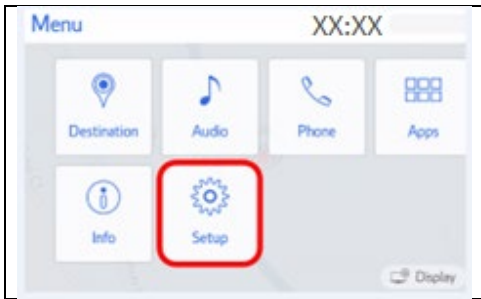
## V. CHECK THE SOFTWARE VERSION OF RADIO & DISPLAY RECEIVER ASSEMBLY

Certain vehicles may not have the infotainment app installed. If the infotainment app is not installed, the submenu (Service) is not displayed, and Over the Air (OTA) updates cannot be performed.

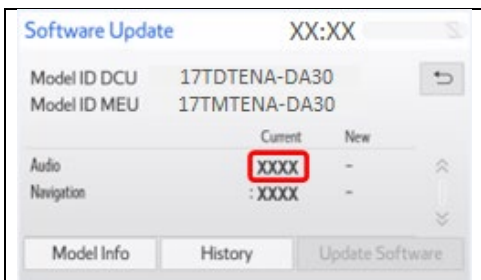
- Check the software version for "Audio" using the table below.
- Close the screen.
- Turn the ignition OFF.

Software Versions		
Item	Current Version	New Version
Audio	Less than <b>1162</b>	<b>1225</b>

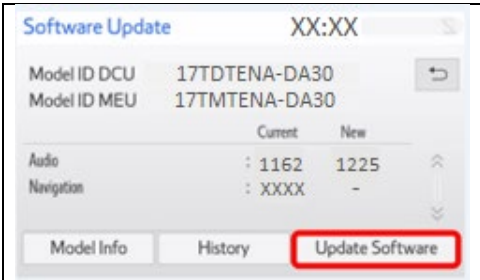
**HINT:**  
"New software was found." is displayed on the screen.

e) Tap "Update Software".
