**SERVICE INFORMATION BULLETIN**

**APPLICABILITY:** All Models

**NUMBER:** 05-91-24

**SUBJECT:** Shock/Strut Leak Diagnosis

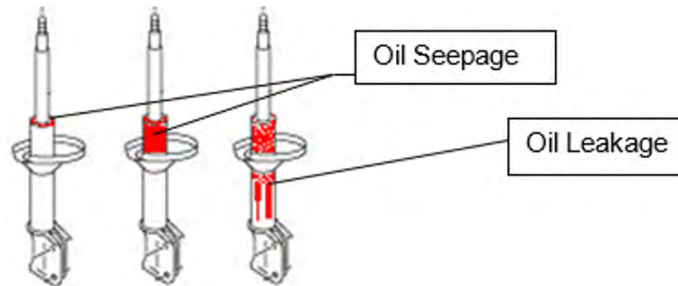
Oil located at the top end of the outer tube and/or oil located just above the spring seat does not indicate a leak condition requiring strut repair or replacement. These conditions are considered normal operation.

If dry dust, without any oil residue visible, is found on the top surface of the lower seat, it is considered oil seepage. This seepage is considered a normal condition and does not require replacement.
