SERVICE BULLETIN

APPLICABILITY: 2017-18MY Impreza
 2018MY Crosstrek
 2018MY Legacy and Outback
 2018MY BRZ*

NUMBER: 15-211-17R

SUBJECT: Reprogramming File Availability for Additional Optimization of Harman Gen 3 Audio and Navigation Head Units

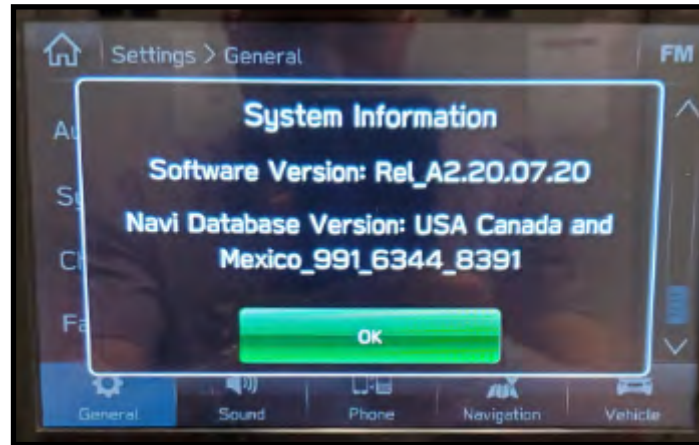
- Confirm the current Software Version ID. If the Current Version is **REL_A2.22.10.20**, **REL_A2.22.39.20**, **REL_A2.23.10.20**, **REL_A2.23.41.20** or **REL_A2.24.12.20** STOP as this latest update has already been installed.

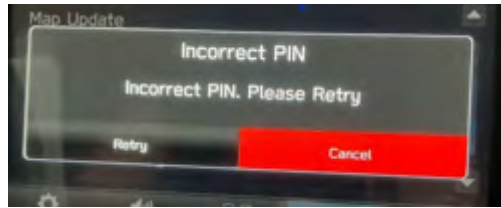
- Poor FM radio reception performance.
- Activation Code Not Accepted by Navigation System when updating Map Data

NOTE (NAVI only): Software version **Rel_A2.22.10.20** is not bundled with the latest map version. If the customer desires to obtain the latest **MAP UPDATE**, install the latest MAP UPDATE software version **Rel_A3.22.05.25** prior to installing software version **Rel_A2.22.10.20**.

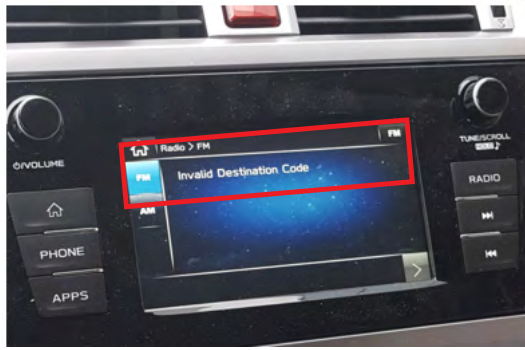
- Update to change “Scan” text display to “Tune Scan” when SXM starts to tune channels.

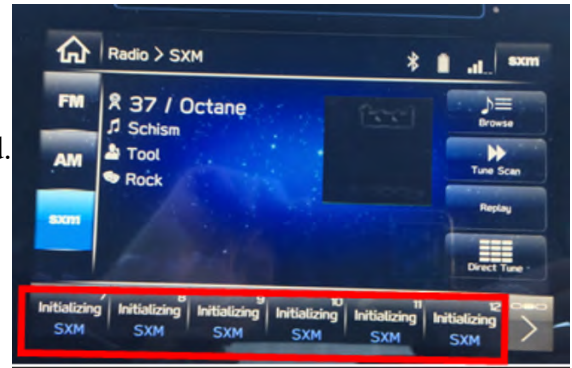
- On 2018MY Legacy / Outback models with Navigation (High) head units, the update corrects a condition where the head unit remains powered even after the ignition is OFF and the driver door is opened.
- Update for a condition where the SXM presets become lost and only “Initializing” appears as shown below.
- Update for condition where only the star field background is displayed (without icons) after the HOME button is pressed.
