SERVICE BULLETIN

APPLICABILITY: 2019-23MY Impreza
 2019-23MY Crosstrek (Including Hybrid Model)
 2019-24MY Forester
 2019MY Legacy/ Outback
 2019-21MY WRX
 2019-21MY WRX STI
 2019-21MY BRZ- Navigation -equipped ONLY
 2019-22MY Ascent

NUMBER: 15-236-18R

SUBJECT: Reprogramming File Availability for Optimization of Harman Gen 3.1 and Gen 3.1α Audio and Navigation Head Units

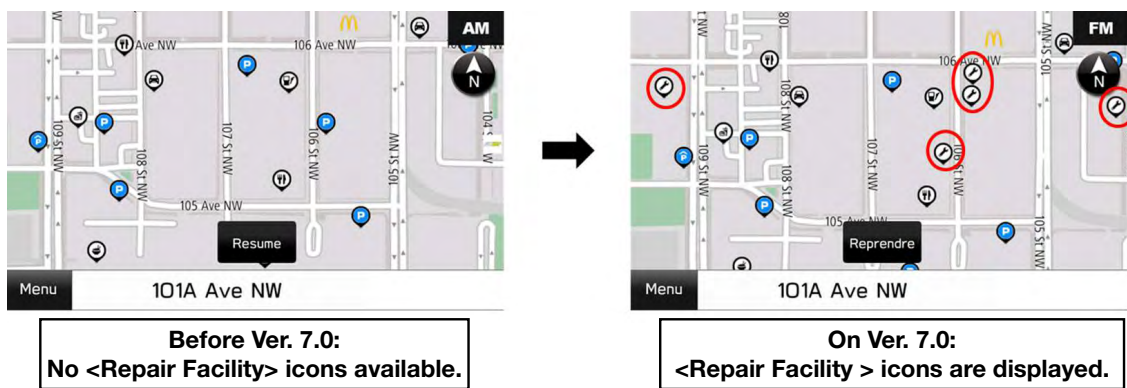
NOTE 4: Displaying Repair Facility POI icons:

<Repair Facility> Icons can be displayed in the NAVI Map.

<Repair Facility> Icons can be turned On or OFF by going to: Settings > Navigation > POI Icons.
