Technical Service Bulletin

60 Sunroof frame modification

60 24 72 2065731/4 July 17, 2024. Supersedes Technical Service Bulletin Group 60 number 23-65 dated April 7, 2023 for reasons listed below.

Model(s)	Year	VIN Range	Vehicle-Specific Equipment
Q3, and Q8	2019 - 2022	All	Not Applicable
e-tron	2019 2021 - 2022		
e-tron Sportback, Q8, and RS Q8	2020 - 2022

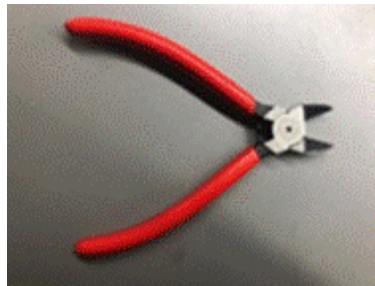
Figure 4. Diagonal cutters (side cutters).

4. Remove the front sunroof glass panel. Using a small pair of diagonal cutters (side cutters; Figure 4) trim away the water guidance washer. The washer must be cut back such that it protrudes no greater than the pivot pin. Perform this operation to both sides.
