**HYUNDAI**
Technical Service Bulletin

| GROUP CAMPAIGN | NUMBER 24-01-047H |
| DATE JULY 2024 | MODEL(S) TUCSON (NX4A) |

SUBJECT: ICU SOFTWARE UPDATE FOR INCORRECT REAR SEAT BELT WARNING LIGHT AND TURN SIGNAL ERROR MESSAGE (SERVICE CAMPAIGN TBX)

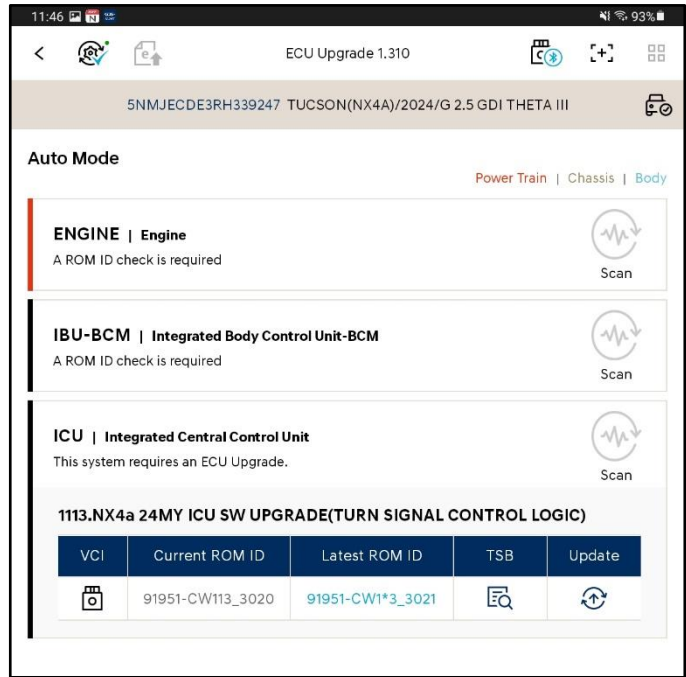
If the upgrade fails, please remove the power connector or the battery (-) connector from the indoor fuse box for at least 5 seconds and reassemble it to retry the upgrade.

3. After the ECU update process shows 100% complete, follow the prompts on the screen to cycle the ignition **OFF** for at least 10 seconds to reset the control unit. (Certain models may take up to 30 seconds.)
