Technical Service Bulletin

GROUP	NUMBER
ENGINE	24-EM-001H
DATE	MODEL(S)
JULY 2024	SONATA (DN8a) SANTA FE (TMa) TUCSON (NX4a)

SUBJECT: DTC P2181 – INTEGRATED THERMAL MANAGEMENT (ITM) REPLACEMENT

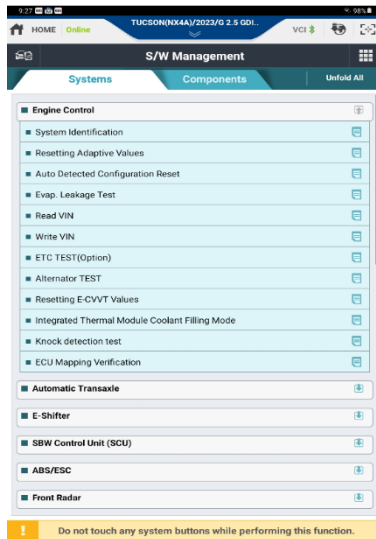
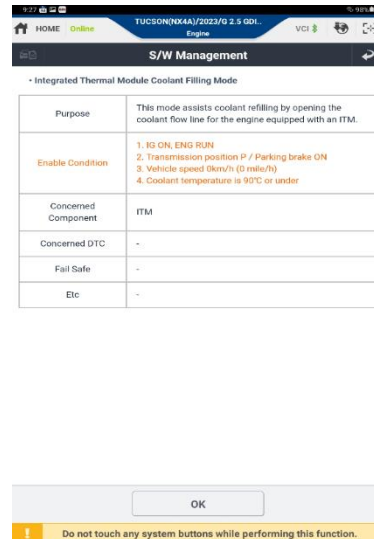
NOTE: Follow the steps below to perform “ITM Coolant Filling Method” with the GDS.

4. Perform an All-Systems Fault Code search and erase the history of the DTC that may have incidentally occurred.
5. Start the vehicle and then perform the ITM Coolant Filling Method to fully air bleed the cooling system using the GDS to enter the “Integrated Thermal Module Coolant Filling Mode”.
