Technical Service Bulletin

GROUP	NUMBER
CAMPAIGN	24-01-061G
DATE	MODEL(S)
JULY 2024	G70 (IK)

SUBJECT: REAR COMBINATION LAMP GARNISH GAP INSPECTION AND REPLACEMENT (SERVICE CAMPAIGN T48G)

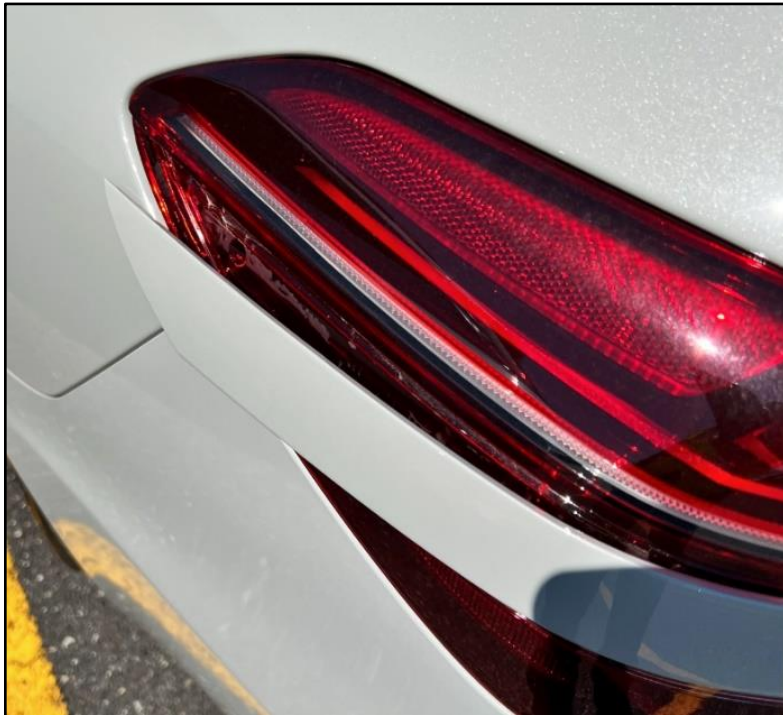
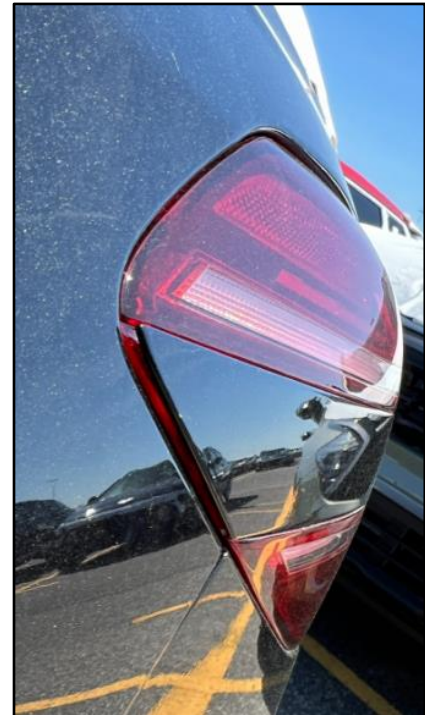
Description: This bulletin describes the procedure to inspect and replace the rear combination lamp garnishes that may begin to detach from the vehicle. The inspection and repair procedure involves confirming if the garnishes have separated and if necessary, removing the garnish and replacing with new parts.
