GROUP	MODEL
BOD	2024MY Telluride (ON)
NUMBER	DATE
329	August 2024

TECHNICAL SERVICE BULLETIN

DOOR BELT OUTSIDE WEATHERSTRIP INSPECTION/REPLACEMENT(SA578)

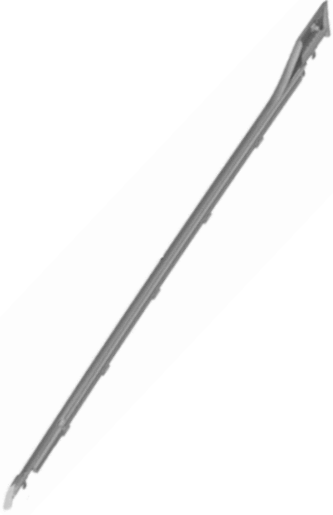
Part Name	Part Number	Figure	Qty.
Driver Front Door Weatherstrip	82210 S9100QQK

1
Passenger Front Door Weatherstrip	82220 S9100QQK		
Driver Rear Door Weatherstrip	83210 S9100QQK		
Passenger Rear Door Weatherstrip	83220 S9100QQK
