# Service Bulletin

Bulletin No.: 23-NA-198

**Subject: HVAC Not Cooling Cabin During a Remote Start**

Brand:	Model:	Model Year:		VIN:		Engine:	Transmission:
		from	to	from	to		
Chevrolet	Trax	2024	2025	—	—	—	—

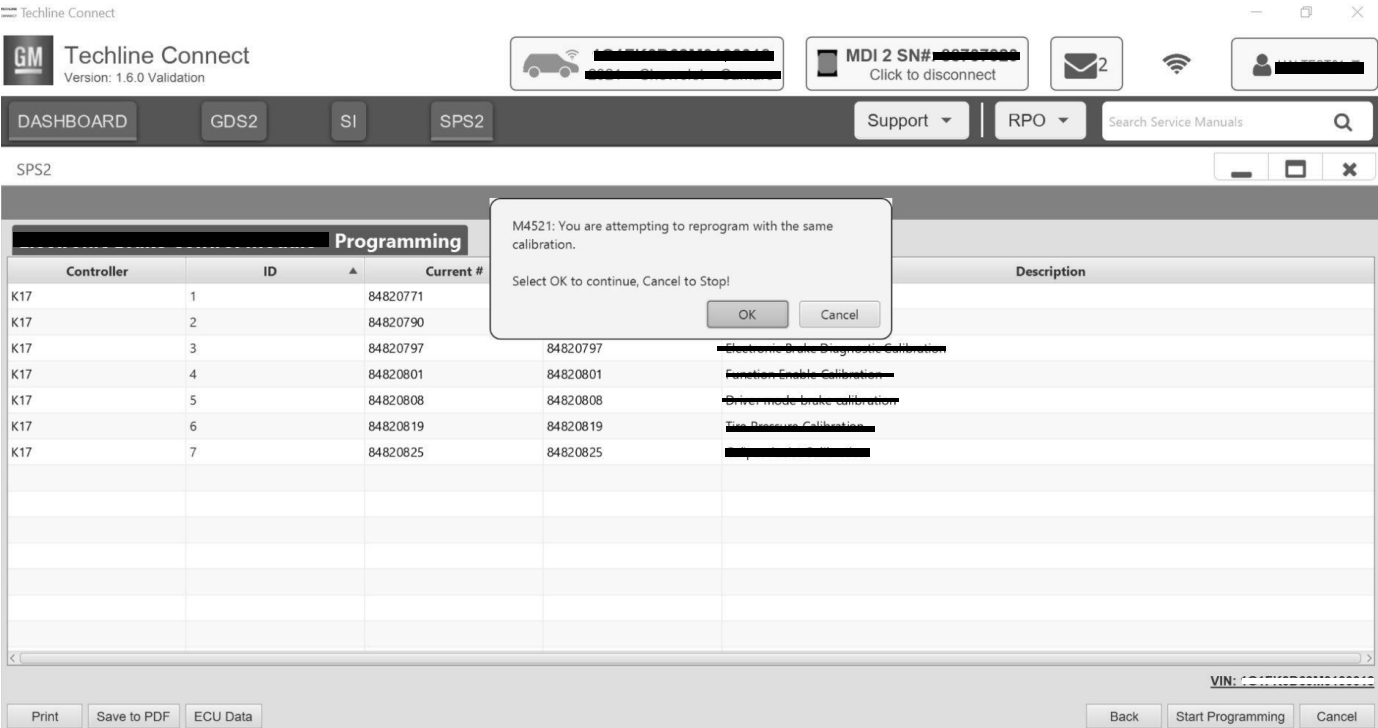
5877000

**Important:** Techline Connect screen shown above.

**Important:** If the same calibration/software warning is noted on the TLC Summary screen, select OK and follow screen instructions. After a successful programming event, the WCC is located in the Service Programming System dialogue box of the SPS
