# Service Bulletin

Bulletin No.: 23-NA-115

**Subject: Ticking, Tapping or Snapping Noise from Engine - 5.5L RPO LT6 Realign Camshaft Caps as Required**

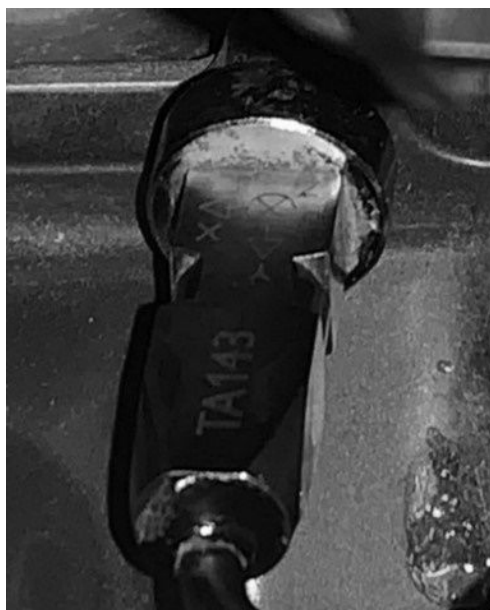
6374737

**Important:** Ensure accelerometer coordinates are facing up towards the intake.

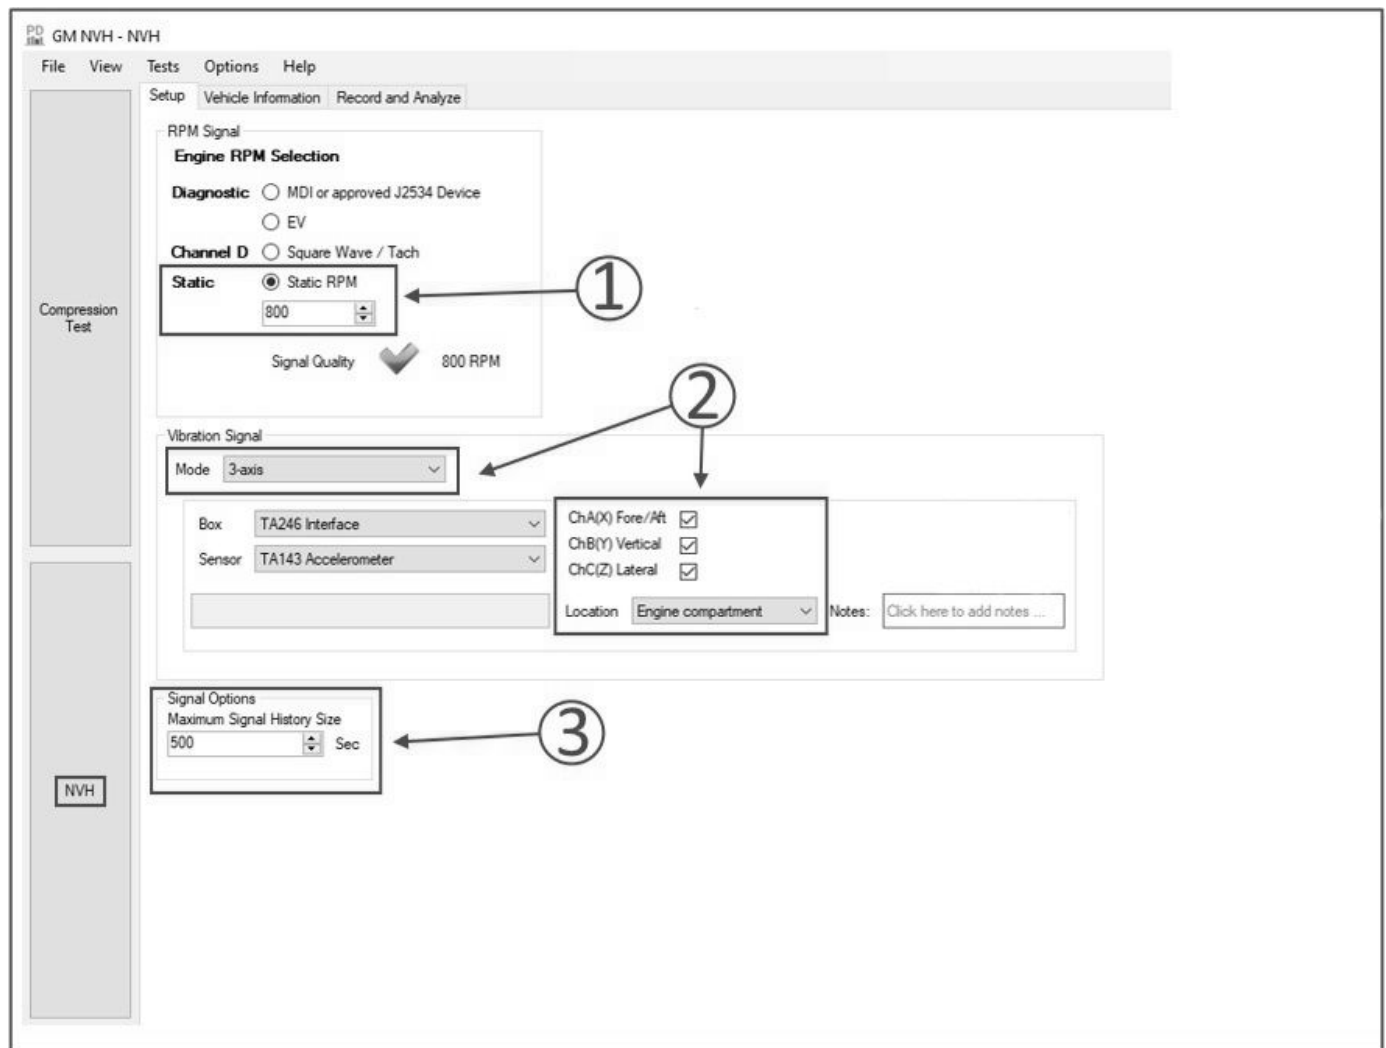
6374911

1. Open the GM NVH software and click on the NVH button.
