GROUP	MODEL
CLI	2021-2022MY K5 (DL3a)
NUMBER	DATE
056	August 2024

TECHNICAL SERVICE BULLETIN

HEATING, VENTILATION, AND AIR CONDITIONING (HVAC) SUBJECT: BLOWER MOTOR FUSE RELOCATION (WTY037)

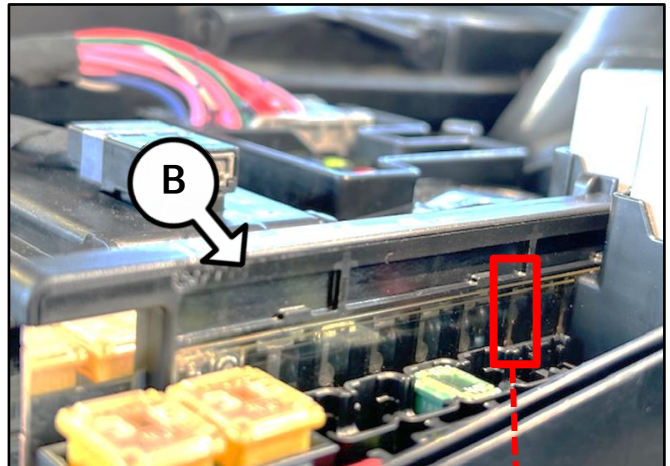
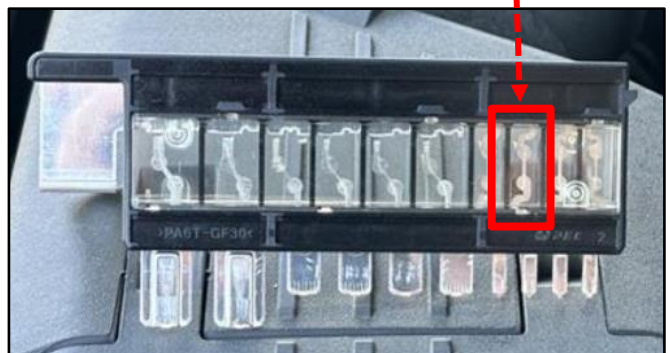
3. Using a flashlight, visually inspect if the multi-fuse location #3 (B) is blown.

- If the multi-fuse location #3 (B) is **NOT** blown, no further action required.
Claim inspection only labor op.
- If the multi-fuse location #3 (B) **IS** blown, proceed to the 'Repair Procedure' on page 2.
