## Lippert In-Wall Slide System

# REPLACEMENT OF THE INVERTED GEAR RACK IN-WALL (SCHWINTEK) SLIDE-OUT SYSTEM

| TSB Number: | 146-001-2022C | | |

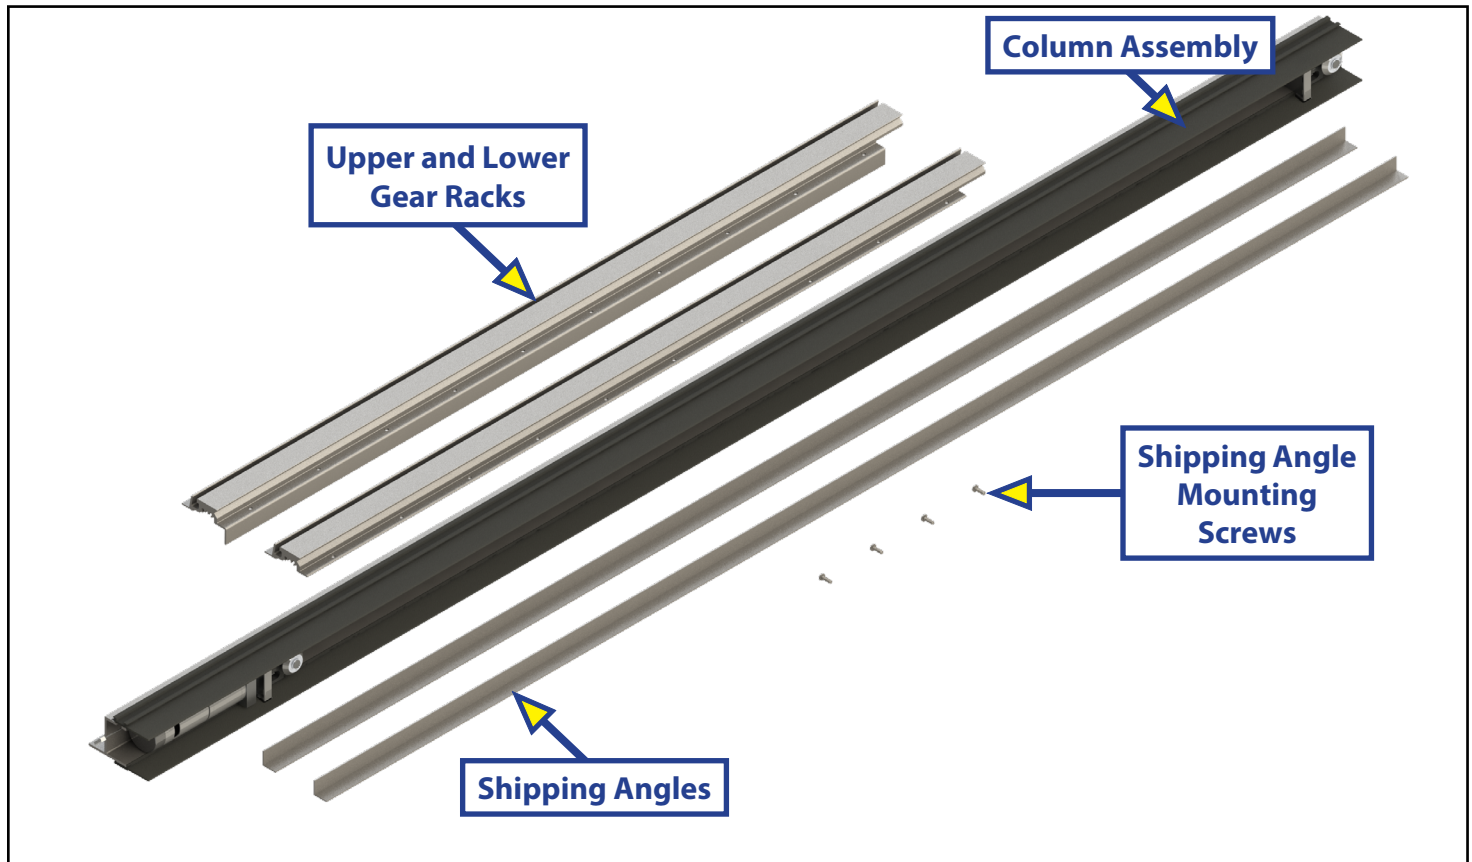
Systems will be shipped partially disassembled in a box or tube.

**NOTE:** Fixed side shown, kit will include Float side assembly as well.

**NOTE:** The kit includes replacements for both the fixed and float sides of the system. It is important to replace BOTH sides and use ALL of the components.
