# TECHNICAL SERVICE BULLETIN

| <b>Subject</b> | 800vRR Vehicle Controller V4.10.2 and ESM V3.0.7 Update |
| <b>Service Bulletin Number</b> | SC-24-009 |
| <b>Description</b> | Software update for the 800vRRs Vehicle and Body Software to reduce the radiator fan current draw to 80%. Additionally fix a bug to properly route ESM faults away from the coolant light icon. |

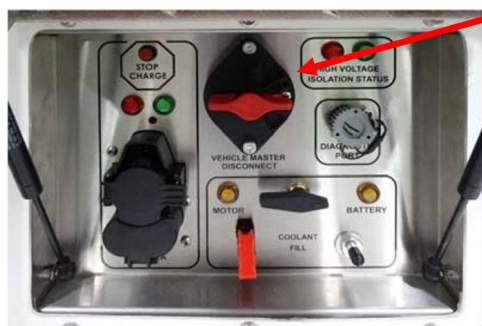
Turn ON the 12/24V rear Vehicle Master Disconnect located at the curbside rear charge port access panel.

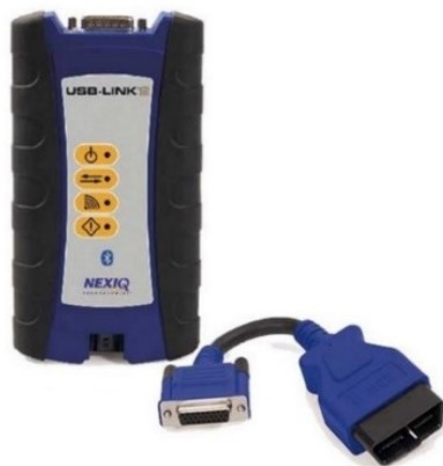
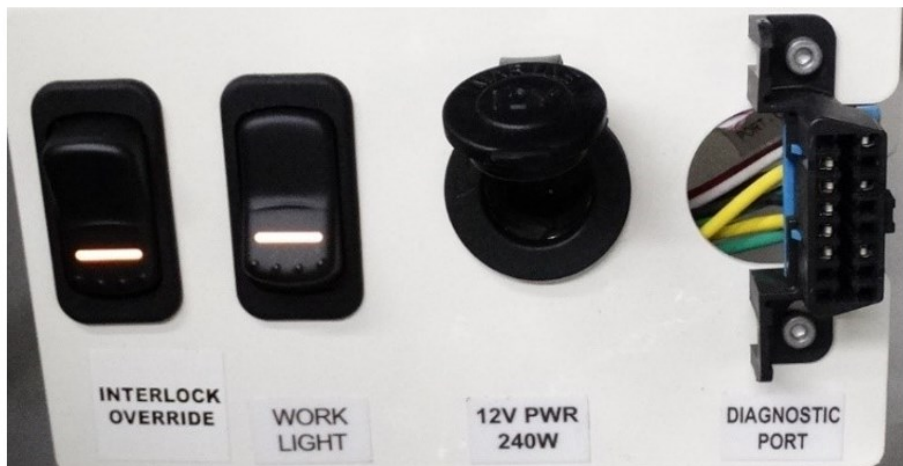
Connect the Nexiq USB Link2 device to the laptop and to the OBDII Diagnostic Port located in the streetside wheel well box

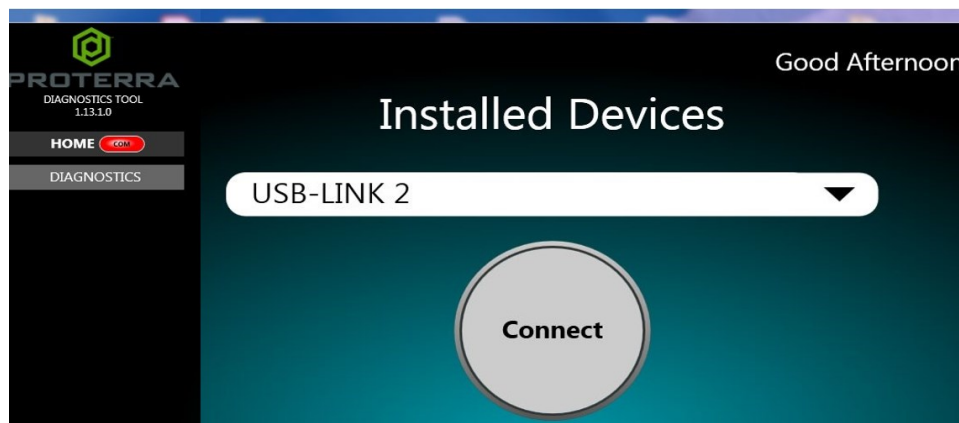
On the Home tab, select the appropriate device from the drop down and click “Connect”.

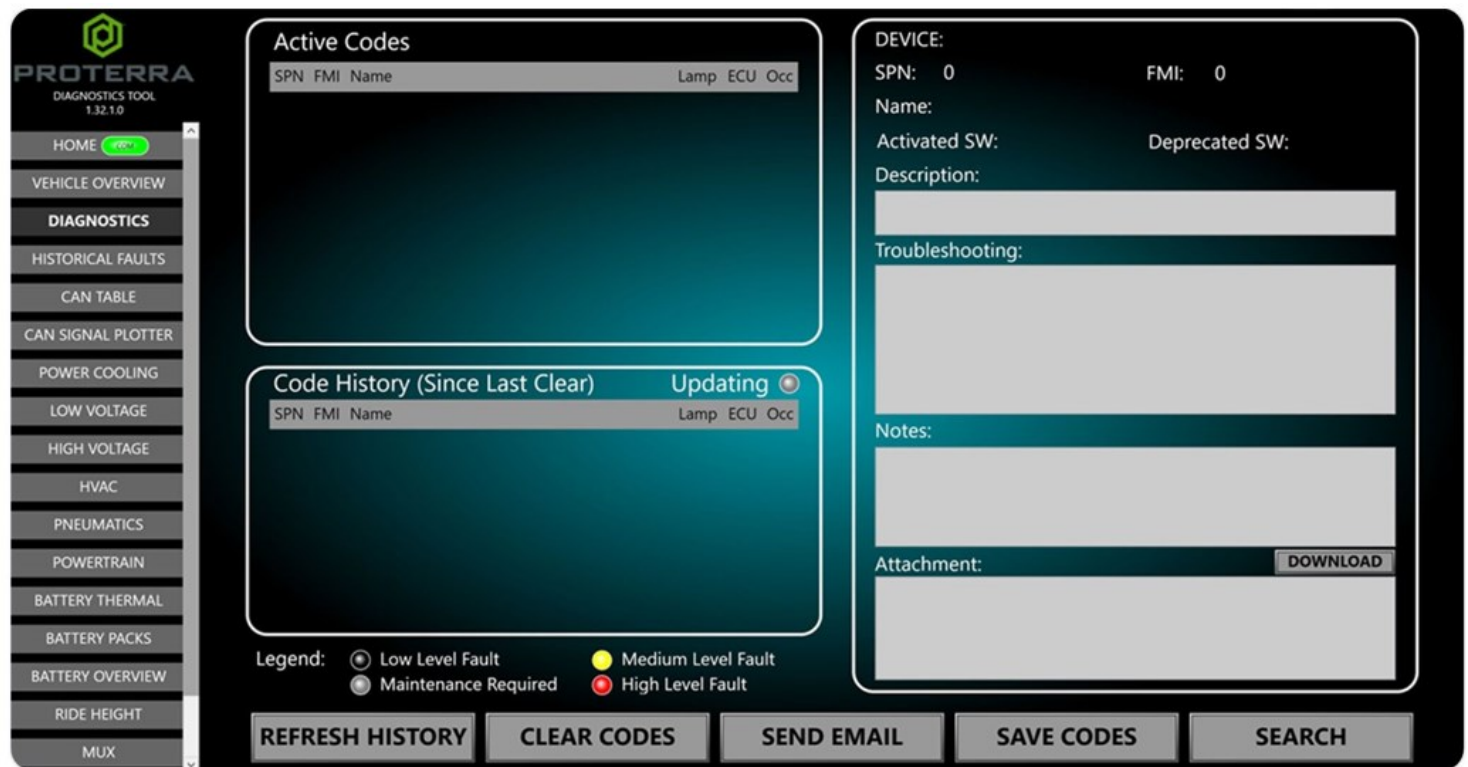
Once the diagnostic tool has connected to the vehicle, a VIN number and connection status will be displayed on the Home screen, and tabs available to navigate. If you do not see the Home Screen, check that the low-voltage batteries are connected and that the Nexiq tool is plugged in.

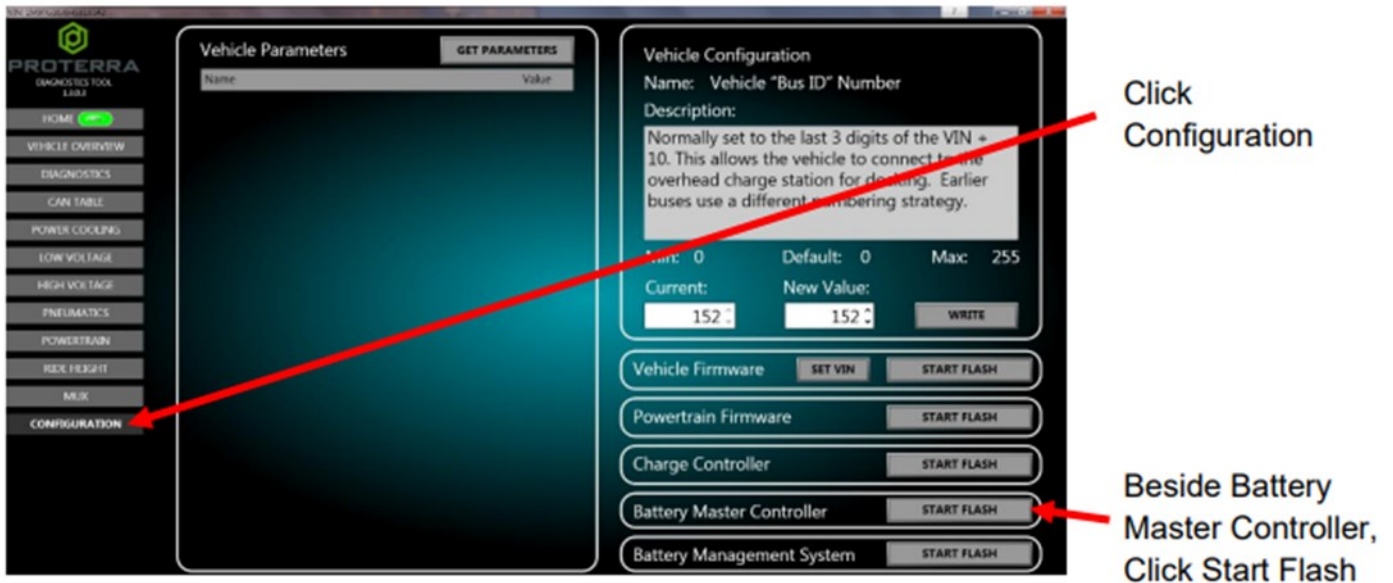
Click on the “Configuration Tab” to open the Configuration screen and then click start flash on the “Battery Master Controller” section.

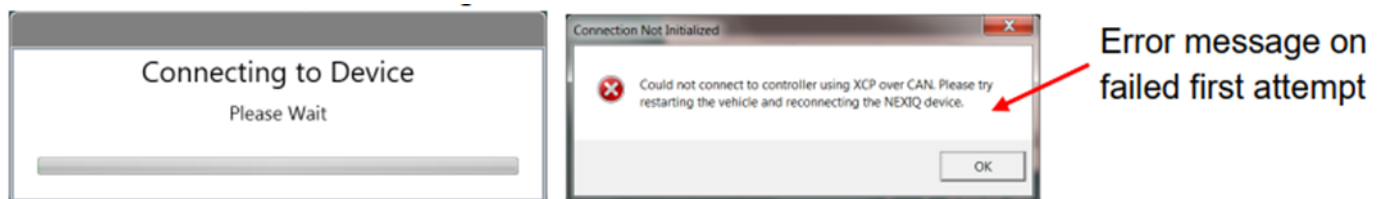
The Proterra Diagnostic Tool will attempt to connect to the device.

NOTE: You may receive an error on the first attempt. If so, retry by clicking the ESM Controller Start Flash button again.

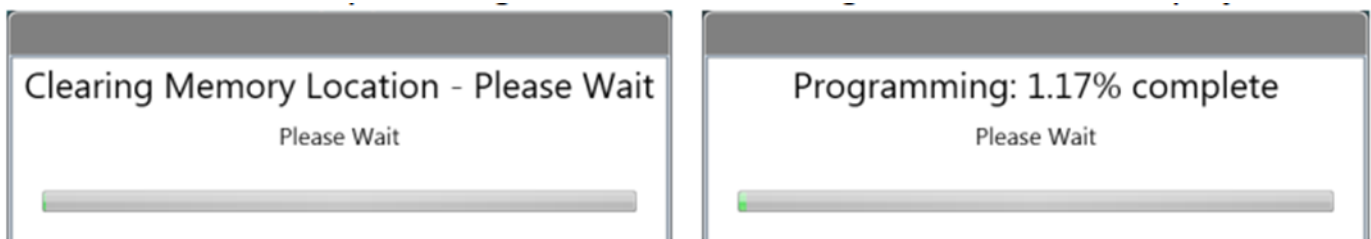
When the software update begins, the following screens will be displayed.

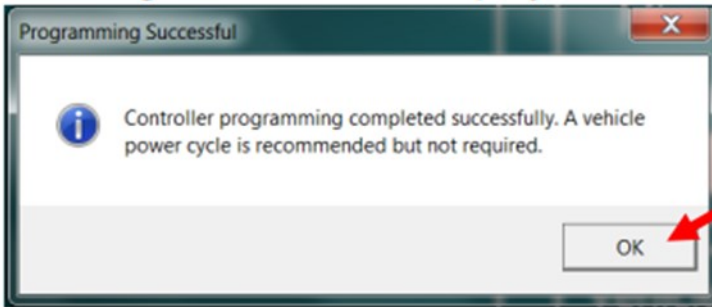
Once the following screen displays the update is now complete.

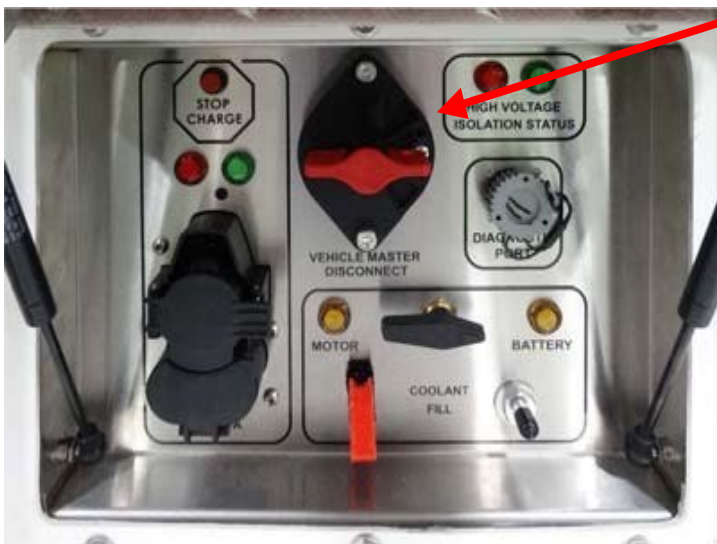
Turn ON the 12/24V rear Vehicle Master Disconnect located at the curbside rear charge port access panel.

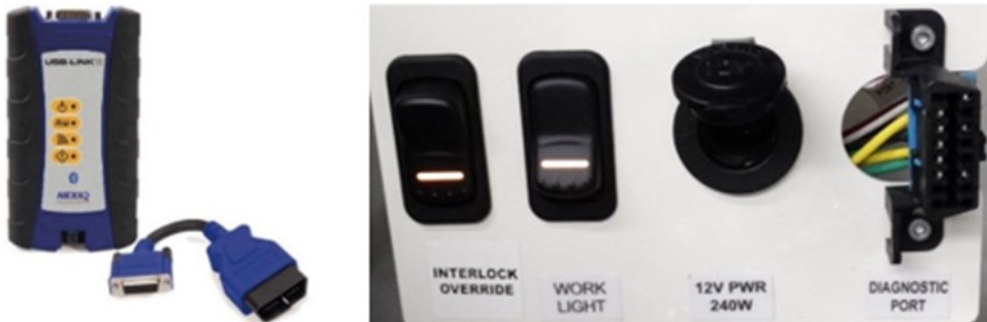
Connect the Nexiq USB Link2 device to the laptop and to the OBDII Diagnostic Port located in the streetside wheel well box.

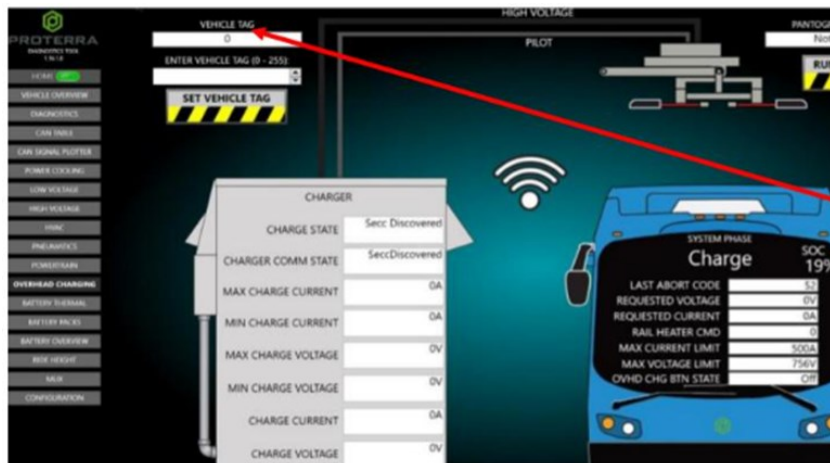
If vehicle is equipped with overhead charging, please use the Proterra diagnostic tool to navigate to the “Overhead Charging” page and record the vehicle tag number. This will be re-entered at the end of this section.

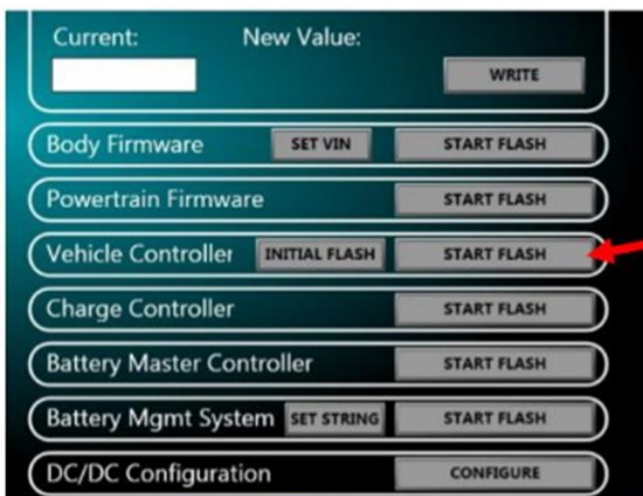
**Beside Vehicle Controller,  
Click START FLASH**

Navigate to the “Configuration Tab” then Click Start Flash for the Vehicle Controller Sections.

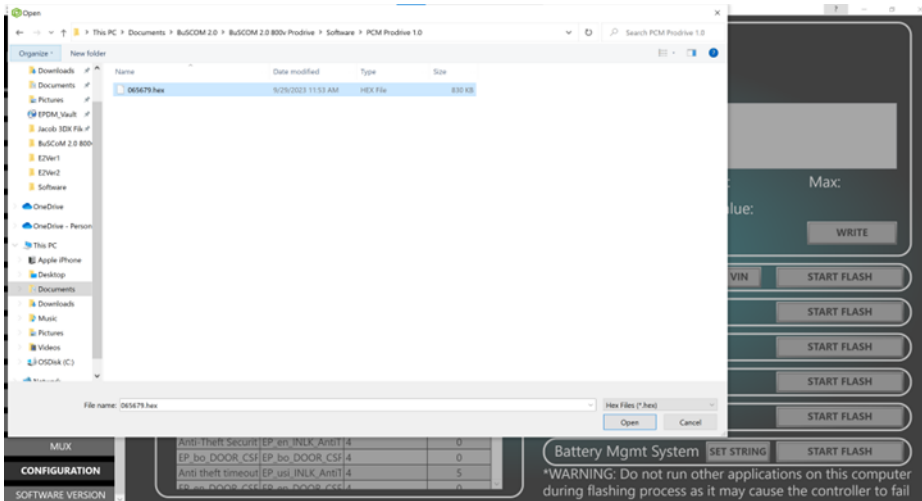
When prompted select file “VIC\_v4.10.2.hex” from your hard drive, select open.

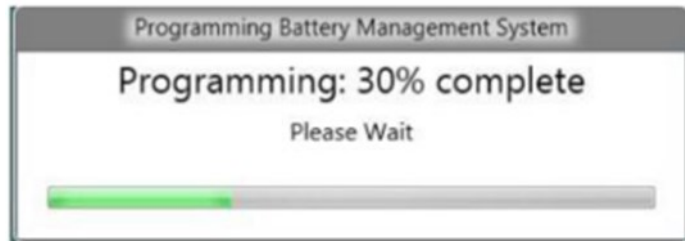
The Programming window will come up and will take several minutes to complete. Its important to note do not switch screens or have any CAN tools to be running in the background.
