GROUP	MODEL
Subsequent Repair Action	2020-2024MY Telluride (ON)
NUMBER	DATE
SC303Z	August 2024

# RIGHT FRONT DRIVESHAFT INSPECTION AND REPLACEMENT (SC303Z)

This bulletin provides information to inspect and, if necessary, replace the right front driveshaft on certain 2020-2024MY Telluride (ON) vehicles manufactured from January 9, 2019 through October 19, 2023 that previously had the campaign SC303 completed. If the subject vehicle exhibits abnormal driveline noise on the right side while driving, open a Techline Repair Assistance (RA) case. Follow the procedure outlined in this publication to inspect and, if necessary, replace the right front driveshaft and bearing bracket assembly on the applicable vehicle. Before conducting the procedure, verify that the vehicle has completed the previously released campaign SC303 and is included in the list of affected VINs.

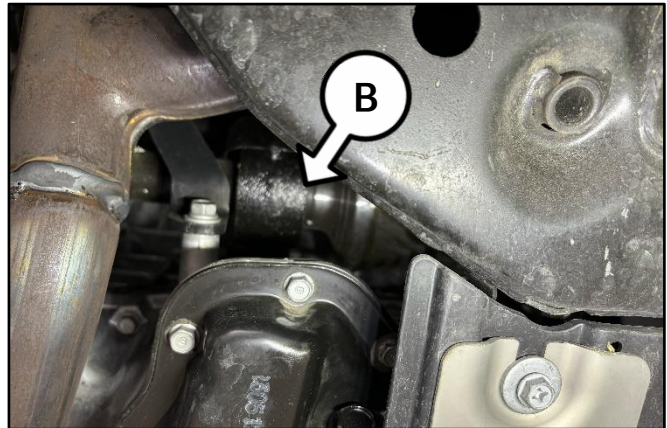
4. The inspection area is shown on the right:

**Note:** It is normal for the end lip of the front driveshaft (C) to either rest flush with the bearing bracket (B) outer edge or be exposed as shown. The exposed distance should not exceed 2mm.
