Technical Service Bulletin

GROUP	NUMBER
CAMPAIGN	24-01-067G
DATE	MODEL(S)
AUGUST 2024	GV70 (JK1A) GV70 ELECTRIFIED (JK1A EV)

SUBJECT: FLOOR CONSOLE UPPER COVER DELAMINATION INSPECT & REPLACE (SERVICE CAMPAIGN T44G)

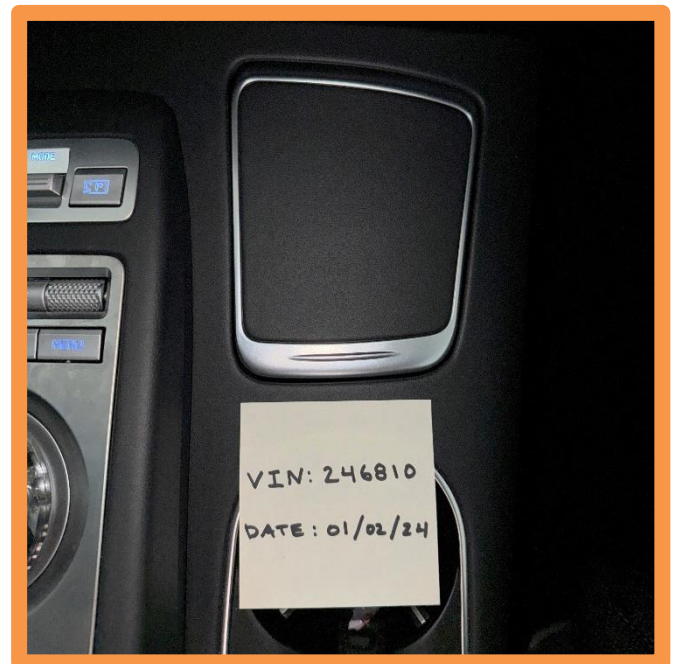
- 1b. **NOT GOOD:** Delamination affects appearance and may hinder compartment opening.

Proceed to “Floor Console Replacement”.

2. Replace the floor console assembly (A).
