| <b>HYUNDAI</b><br><b>Technical Service Bulletin</b> | GROUP<br><b>CAMPAIGN</b> | NUMBER<br><b>24-01-073H</b> |
| | DATE<br><b>SEPTEMBER 2024</b> | MODEL(S)<br><b>SONATA (YFA)</b> |
| <b>SUBJECT:</b> REAR COMBINATION LAMP INSPECTION & REPLACEMENT<br>(WARRANTY EXTENSION TXXT) | | |

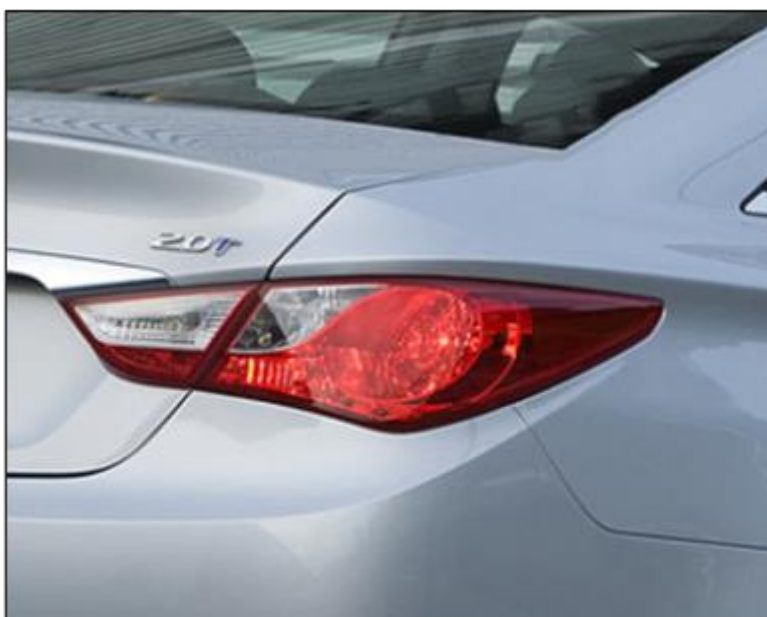
**Description:** Some 2011-14MY Sonata (YF) vehicles may exhibit inoperative brake lights that may be caused by melting/deformation of the rear combination housing lamps.

Follow the service procedure in this TSB to inspect the rear combination lamps and, if necessary, replace them if heat deformation is found.

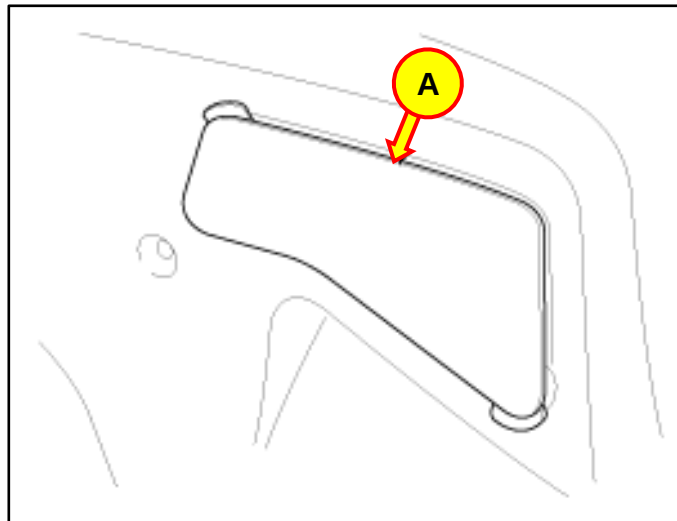
1. Record customer's audio presets, then disconnect the negative (–) battery cable.
2. From inside the trunk, remove the cover (A) of both the LH and RH rear combination lamps.

3. Remove the stop lamp socket from the LH and RH housing and inspect for any signs of heat deformation.

Heat deformation around the bulb housing opening may vary. The discoloration of the bulb socket alone does not necessarily indicate this condition.

6. **If heat deformation is present on either lamp**, replace **both** the LH and RH combination lamps.
